Marine Safety Flash

A16-39 (14th September)

Fall in the engine room

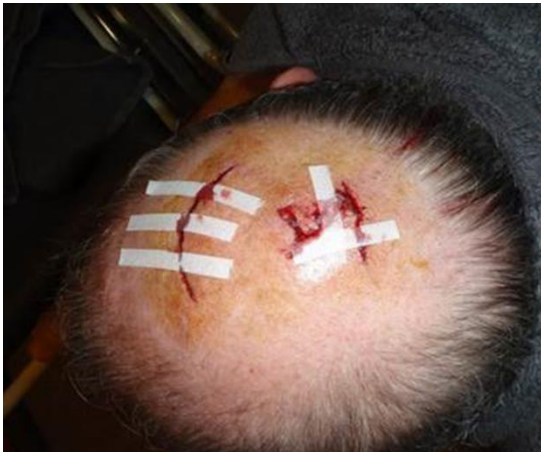
Figure 1: Lacerations to Scalp

The IP sustained several lacerations (figure 1) to the top of his scalp and received first aid treatment on board.

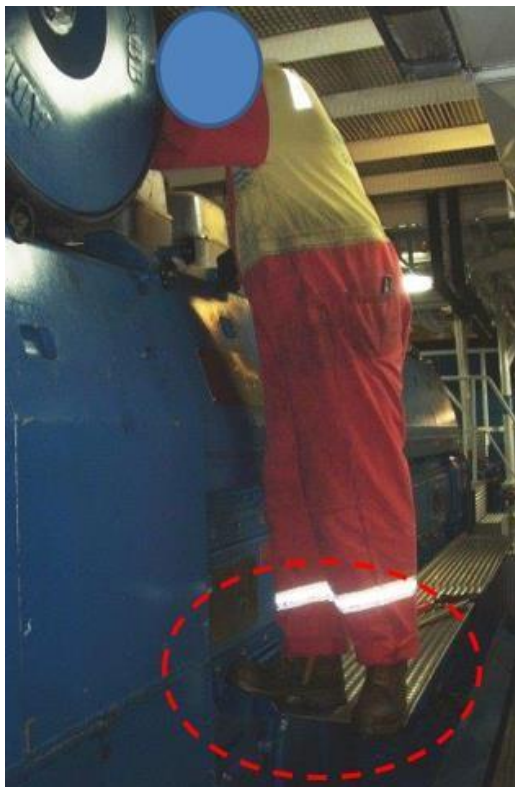
Figure 2: Foot Placement

- The IP was reaching out with the socket wrench to open the indicator cock when he lost his balance and tipped forward. As per figure 2, the IP has his feet positioned at the very edge of the platform, slightly overhanging the platform. The IP does not recall exactly what made him falls forward, however it is assumed that the IP misplaced his footing whilst focused on the task of opening the indicator cock.

- There is no information about the use of specific PPE in the engine room.
- Hazard Identification Team to conduct hazard round focusing on fall hazards, in particular heights that would not be captured with the Working at Height, Aloft or Above Sea Procedure.
- A kick plate or extension to be fitted to the platform.
- If your vessel has a similar hazard onboard, update your vessels ship specific inherent hazard list to include the fall hazard until a long-term solution has been identified.

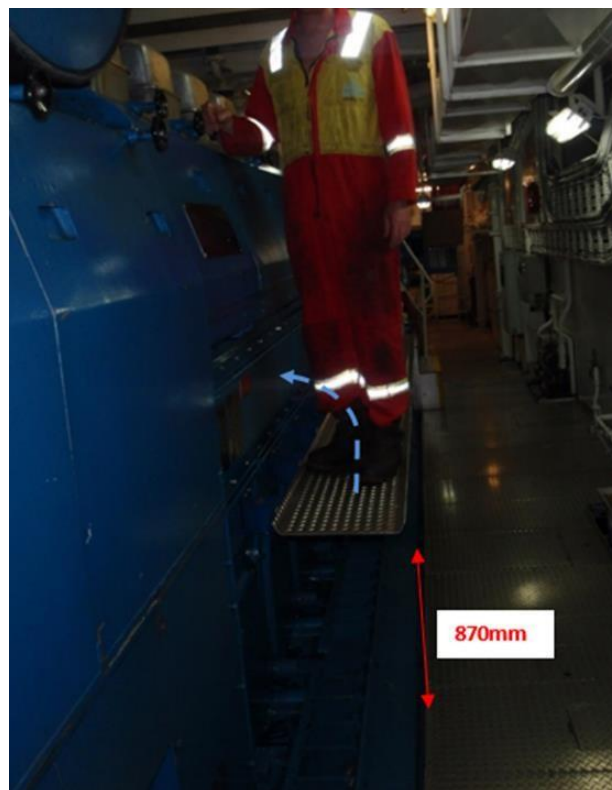
Figure 3: Engine Mounted Platform

- The platform finishes short of the indicator cock the IP was gaining access to it. The platform is supplied by the manufacture of the engine. The length and height of the platform has not been identified as a hazard previously. The height of the platform is below 1m and it is routinely used by engine room staff with no previous incidents or near misses. As the platform was not previously identified as a hazard there were no controls in place to prevent a fall at the end of the platform (kick plates, hand rails etc.).
