Marine Safety Flash

A17-03 (12th June 2017)

Fire in Engine Room

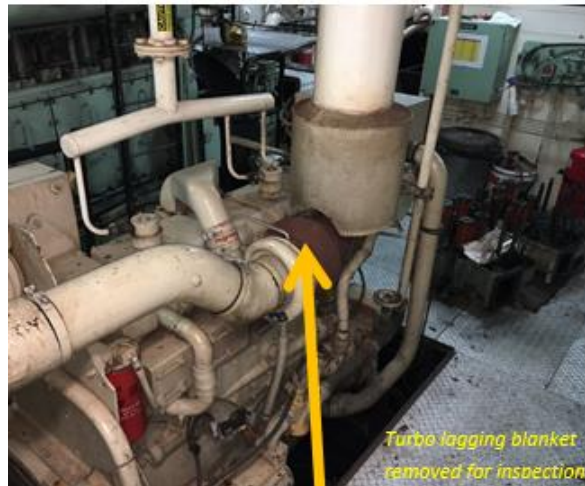
The Engineer and GPH attended to investigate and observed wispy white smoke and small orange flames around the turbo exhaust manifold lagging.

- Engine shut-down on high coolant temperature (approx. 105 °C). A hot spot was created on the exhaust manifold causing the surrounding dust and oily grime to smoulder and then ignite underneath the lagging.
- Air trapped in the seawater side of the cooling system on this engine lead to cavitation and inefficient cooling.
- A build-up of grime, dust, etc. around the manifold provided sufficient fuel to convert the high temperatures into a fire.
- Although damage was superficial and minimal, there was obvious potential for a larger fire.

- Raising general awareness of this incident and causal factors through a Safety Flash.
- PMS work instruction for similar tasks amended to include close monitoring by Engineer during initial start-up and operation of such equipment.
- During next Safety Area Inspection, pay particular attention to greasy, oily grime build-up around machinery spaces, particularly near high temp areas such as exhaust manifolds as well as a focus on general engine room house-keeping.
