# Marine Safety Flash

A17-05 (17<sup>th</sup> July 2017)

## Shark Jaw Failure

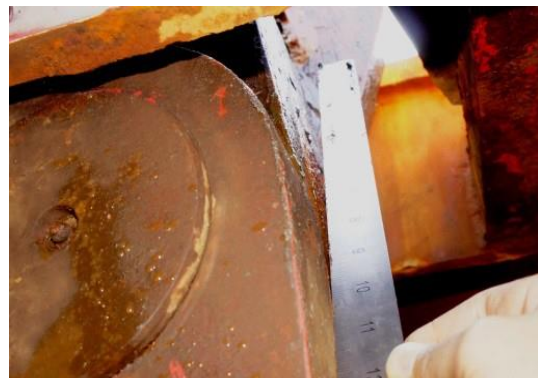
Picture of shark jaw mechanical link IN its over center position and position of proximity sensor when in locked position (Green light is on)

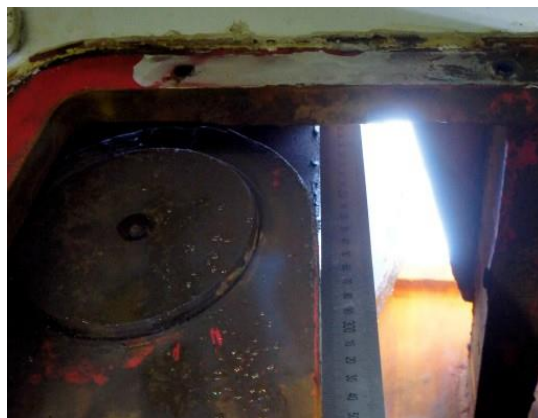
- Loss of pennant Wire - Due to internal leak in the port shark jaw hydraulic cylinder; it gave way while holding pennant wire socket lead to loss of pennant wire.
- Port shark jaw hydraulic cylinder was found to be leaking internally.
- No audible alarm on the shark jaw panel when the locking indicator light went off.
- Work description in the PMS for the task needs improvement to include; test to verify if there was any internal leak inside the hydraulic piston and piston rod to be cleaned & lubricated during monthly inspection and after every anchor handling operations.

Picture of shark jaw mechanical link OUT of its over center position and position of proximity sensor when the shark jaw gave up (Green light is off)

- Preventive Maintenance needs improvement: As per PMS (based on maker's recommendation) the piston seal is to be renewed every 5 years. However, the hydraulic piston seal lost its integrity before 5 years.
