# Marine Safety Flash

A17-06 (17<sup>th</sup> July 2017)

## Back Deck Operations – disconnection of equipment

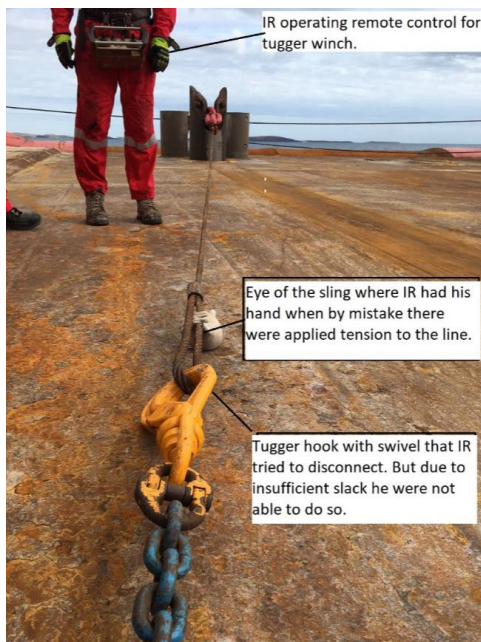
After receiving a PCP and securing the 76mm chain tail in the shark jaw. A crewmember was disconnecting the sling, which was passed down with the PCP.

The crew members hand was holding onto the eye of the sling and attempting to disconnect the tugger hook. There has been unexpected tension on the line and the crewmember's finger has been crushed causing a fracture. This event has the potential in any lifting operation. Situational awareness, due care, clear communication and diligence must always be applied.

- Consider your grip when disconnecting and connecting hooks;
- Maintain clear communications between machine operators and personnel performing manual handling. Do not become task focused, remember to look up and around;
- Always communicate with others when putting on or relieving tension on a line;
- Always keep yourself out of the line of fire;
- Maintain situational awareness when using machinery;
- Always ensure all safe guards are in place when tensioning loads;
- If you are unsure stop work and seek assistance.
