Marine Safety Flash

A18-01(10th Jan)

Electric Shock - FAC

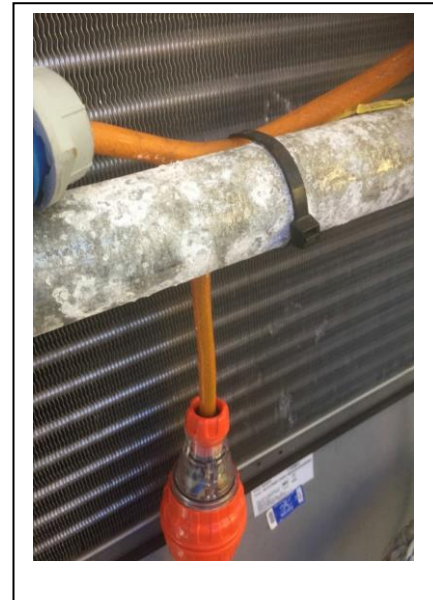
Water observed to have partially filled male coupling.

Male and female couplings were not screwed together tightly.

Cable and couplings were fixed in vertical configuration and exposed to heavy rain.

Coupling ends were not of same brand and female coupling (unbranded / unidentifiable) did not appear to have adequate weather sealing and IP rating was not identifiable.

Site walk-down completed with Company and Contractor Inlecs and Electricians to identify equipment requiring further inspection.

1. All electrical equipment to be fit for purpose (IP56 for external use) and compliant with manufacturer specifications.
2. All temporary electrical cabling and similar couplings to be inspected by competent and authorised personnel and where required;
3. Unbranded / unidentifiable equipment removed from service
4. Moved to an appropriate location, least exposed to weather run off
5. Replaced where identified as defective (according to manufacturer specifications)
6. Reconfigured to 'drip loop' configuration where practicable.
