# Marine Safety Flash

## A18-02 (10<sup>th</sup> Jan)

### Damaged Chain Block

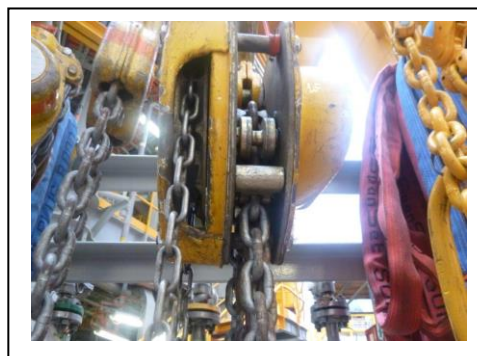
During the preparation of transferring a load from one chain block to another, an unloaded 3 tonne WLL chain block was being lowered when the chain bunched up inside the block and the chain guide roller became dislodged. The guide roller was retained within the block mechanism.

There is evidence of a potential design issue in some EXO 3 tonne WLL chain blocks. The chain end anchors do not incorporate stoppers that prevent the chain end anchor being drawn into the block mechanism. This can cause a jam up of chain and potentially lever the block cheeks apart, allowing the load chain guide to come free.

- Job was stopped, work area was made safe
- Chain block was tagged out and removed from service
- Riggers Leading Hand and Night Shift Supervisor were informed
- All Exo chain blocks were inspected and suspected failure type removed from service
- Chain block provided to independent third party for analysis and confirmation of potential cause
