Marine Safety Flash

A18-04 (15th Feb)

Vessel Allision Event

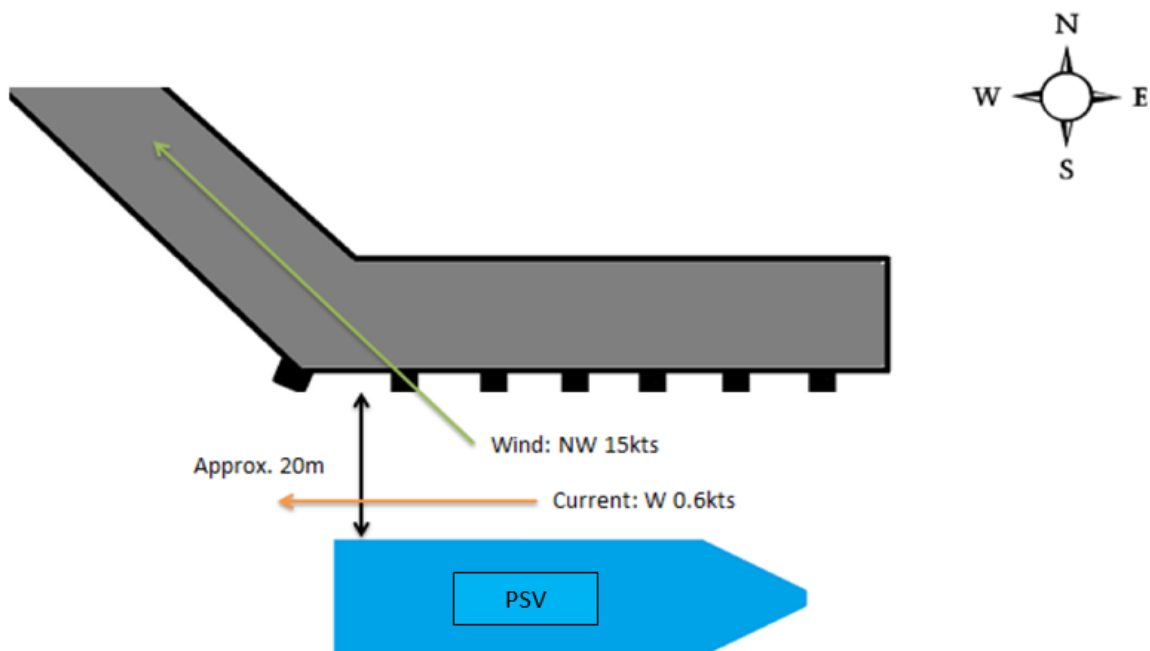
Diagram 1: position of vessel prior to final approach and change of operator station

During port-side berthing operations of a platform supply vessel (PSV) alongside a supply base, contact was made with the vessel port quarter and the wharf following incorrect transfer of controls from the forward to aft station. This resulted in the port azipull not being available at the aft station whilst the starboard azipull thruster was already engaged to push alongside. This resulted in the vessel hitting the wharf before the port azipull had a chance to slow the stern sliding towards the berth.

- (1) Although a risk assessment was carried out, there was no clear consideration in the planning of the operation towards adequate bridge resource management (BRM), including when changing command from forward to aft.
- (2) The port-side forward azipull control lever was not at 'zero' prior to change of conning station, resulting in the inability to take command aft.
- (3) The testing of the equipment readiness immediately following command change was not implemented until the need for use.
- (4) The vessel was in close proximity to the wharf prior to change of command stations, resulting in limited time to correct any issues.

- Ensure the Company safety management system and relevant procedures/checklists call for consideration to robust BRM techniques, particularly during critical task.
- Ensure vessel built in safety systems/interlocks are well known by all bridge team members, including all equipment associated with a change in conning command. Additionally, back-up systems available such as non-follow up.
- Ensure vessel set up prior to approach is in all respects tested fully operational and the vessel is at a safe distance such that any deficiency can be rectified or the operation safely aborted.
