Marine Safety Flash

A18-05 (15th Feb)

High Potential Electrical Event

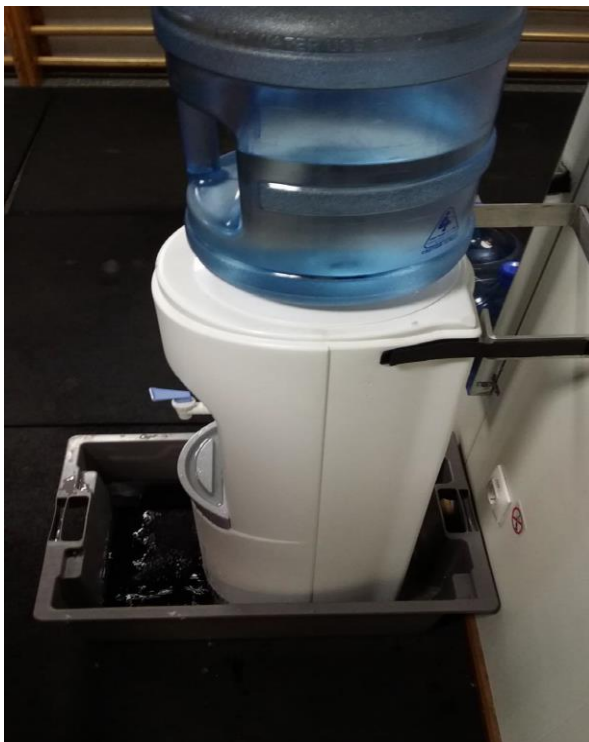
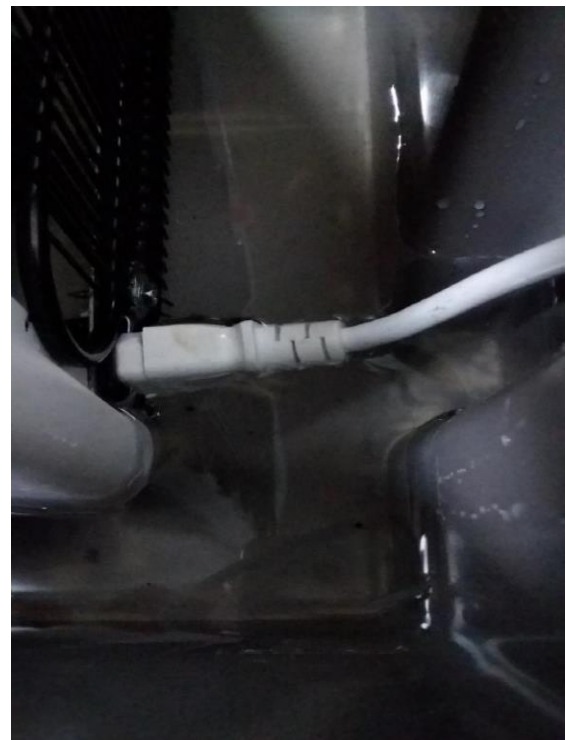
A leaking water cooler located in the gym of an offshore vessel had leaked so much water that the 230V power input leading into the lower rear of the machine was immersed, resulting in an earth fault. See below photos.

- (1) The event was identified through a 230V earth fault.
- (2) This water cooler was previously removed due to leaks. It was put back, in a secondary containment to catch the leak.
- (3) There was no formal assessment of additional hazards/risk this may impose.
- (4) The water level in the secondary containment was not monitored, resulting in the power supply connection being immersed.
- (5) High potential of electrocution / personal injury.

- The equipment was immediately isolated and removed from service.
- Faulty equipment should be condemned or properly repaired before re-instatement. Adding secondary containment to any leaking source is not addressing root cause and not a sufficient control.
- Improve ships husbandry, hazard inspection and training of shipboard crew on management of change, particularly highlighting the assessment of new hazards a change may bring.
