Marine Safety Flash

A18-06 (15th Feb)

Workboat Fuel Contamination

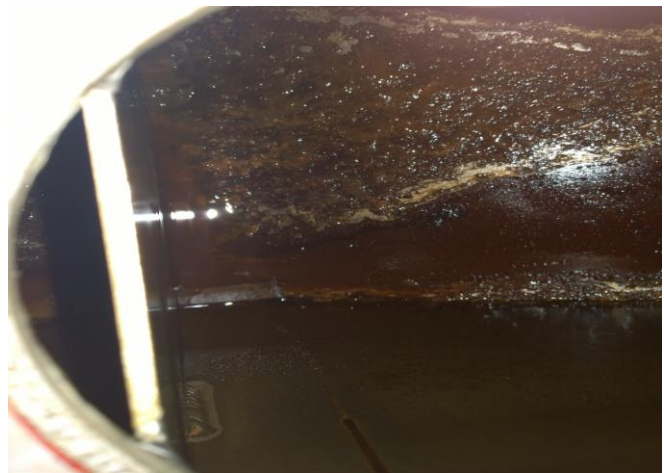
Once onboard, the vessel's Engineers conducted an investigation / fault finding on the work boat. During the investigation, the Engineers discovered that the fuel in the tank was contaminated due to water condensation causing a bacteria buildup.

- **Source of Contamination:** Water / moisture in tank was due to condensation in the tank head space; this resulting in a buildup of bacteria turning into sediment. The sediment caused the fuel oil fine filter to clog preventing the engine from starting.
- **Planned Maintenance System (PMS):** The instructions within the PMS regarding inspection and maintenance were clear, however had not been followed as per the requirements.
- **Spare Filters:** The vessel did not hold spare filters onboard.

- Check fuel and tank quality through planned maintenance inspections, treat and / or clean as applicable.
- Ensure FRC fuel tank levels are maintained to prevent condensation / water building up.
- Ensure a stock of essential fuel filters are held as stock onboard.
