Safety Flash A12-01

Issued: 17th February 2012

Subject: Incorrect oxygen bottle operation and 'near adiabatic compression'

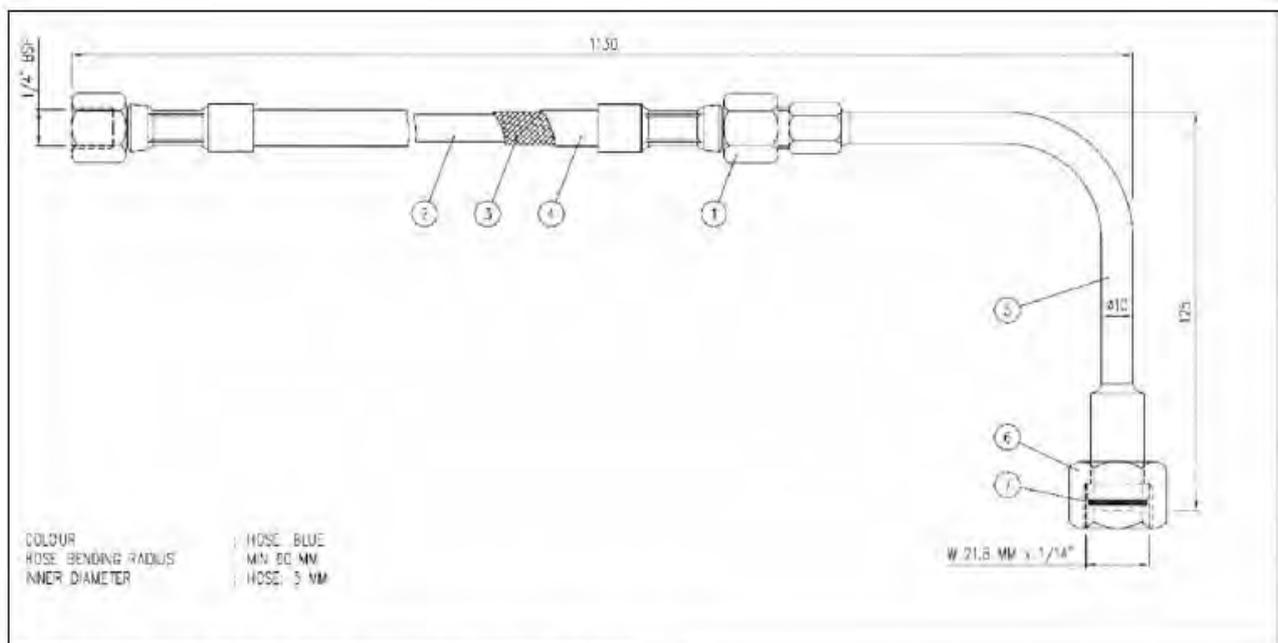
Fig 1

The C/E and 2/E wished to use the oxy acetylene equipment. With the 2/E standing behind him, the C/E reached into the oxygen locker and opened the valve on the oxygen bottle by one complete turn. He then reached up and opened the regulator assembly valve and at that point he observed a blue and yellow flash/flame running along and under the Hytrel PTFE sheathing which is the outer insulation cover of the high pressure hose joining the bottle to the regulator. Almost immediately afterwards a small explosion occurred as the hose blew off the ferruled fitting of the elbow at the oxygen bottle end (Please see figs 1 & 2).

The hose failed at the elbow socket (position 4 above)

Following the review of an independent post-incident hose inspection report undertaken by the hose supplier, and analysis of historical data from previous accidents of this nature; it has been concluded that the primary cause of the blowback was due to “near adiabatic compression” occurring in the high pressure hose when the C/E quickly opened the cylinder valve against a closed regulator assembly valve.

It is also most likely that, as the high pressure hose had been in service for 5 years (it was due to be replaced within days of the accident occurring) and no doubt numerous oxygen cylinders had been changed out on this hose assembly, there had been local weakening of the hose at the elbow connection. This would have been due in no small part to stresses introduced at cylinder changes and possibly due to incorrect bending causing local stresses in the braiding at the elbow connection. This can only be an assumption as the hose as previously stated had been removed from the installation after the incident, and before investigation, such that the actual bending stresses on the high pressure hose cannot be conclusively determined. The point of local weakening, however, can most likely be attributed to the cumulative effect of associated oxygen bottle removal / replacements over the life of the hose.

Precise instructions have been posted on the bulkhead and written into procedures that under no circumstance is the oxygen bottle valve to be opened rapidly against a closed regulator assembly. These valves should be ‘cracked’ and very slowly opened to introduce the oxygen in a controlled and stable manner.

That all oxy-acetylene systems should be checked immediately with a special emphasis on reducing any bending stresses on the high pressure hoses, and that they should be installed exactly as shown in Figure 3. Additionally, hoses to be replaced every 5 years or as per manufacturer’s instructions and only correct type of hose to be used. It is very important that no substitutes of any description are used.
