Safety Flash A12-03

Issued: 15th February 2012 Subject: Hand injury

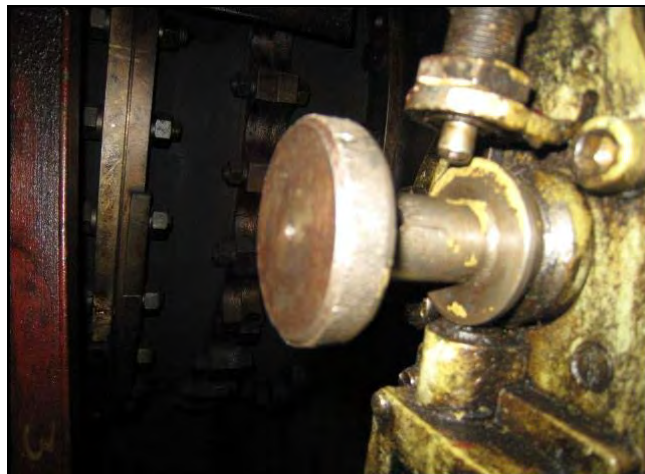
The Injured Person (IP) was carrying out camshaft inspections on a Main Engine. Whilst moving the turning gear wheel to enable visual inspection, the wheel was found to be sticking somewhat.

Turning Wheel

Turning gear wheel did not turn fluently may have been used to move hands from impact zone

- Use the right tool for the job – a 'correct' tool has been made for the job, which is a bar that fits into (a pre-existing hole on) the original handle.
- Review the SJA/JSA and adjust accordingly to encompass use of the tool.

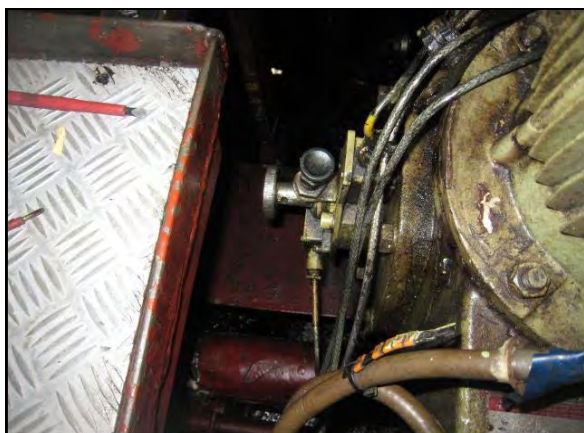
Machinery Space for cam shaft inspection

Tight work area which is down low with a lot of square steel edges

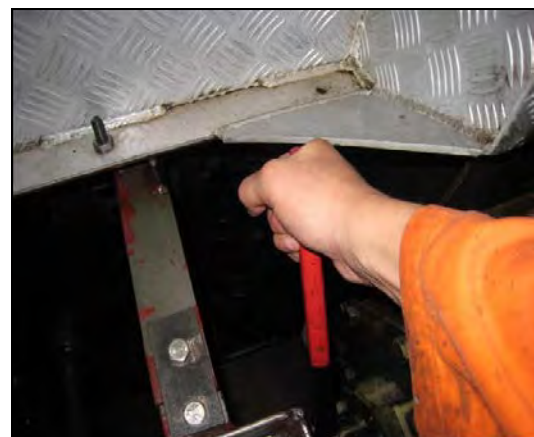
A pair of multi-grip type adjustable pliers was sourced to enable more leverage and grip to free up the movement of turning gear knob. As force was applied, either the grips slipped or the wheel turned; this caused the IP's right hand index knuckle to come in contact with an aluminum guard.

Re-enactment of the point of impact
