# Marine Safety Flash

## A13-01 (15<sup>th</sup> February)

### Cut Finger on Electrical Binding

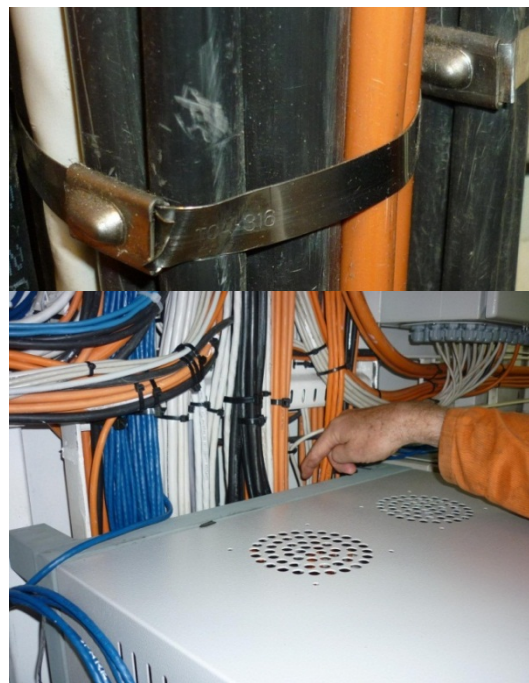
- The termination of the steel strapping had been left with exposed sharp edges.
- The inherent cut hazard of these bindings had not been identified prior to commencing this task.
- As a result, no hand PPE was employed.

Figure 1 & 2: Steel strapping and area where incident occurred.

- (1) Every task will carry a degree of risk.
- (2) Prior to any task, the work scope is to be subject to a form of risk assessment to ensure controls can be put in place to minimise the likelihood of an incident. JHA for this task to be reviewed and updated.
- (3) Appropriate PPE should be worn depending on the outcomes of risk assessment.
- (4) Inherent hazard presented by stainless cable ties to be recorded in inherent hazard log and included in crew induction.
- (5) Control method for this risk is use of on-board PPE and crew are to be refresher trained on available gloves.
- (6) Feedback to be provided to vessel new build electrical superintendent regarding identification and elimination of this hazard for future vessels at new build stage.
