Marine Safety Flash

A13-02 (15th February)

Dropped Objects

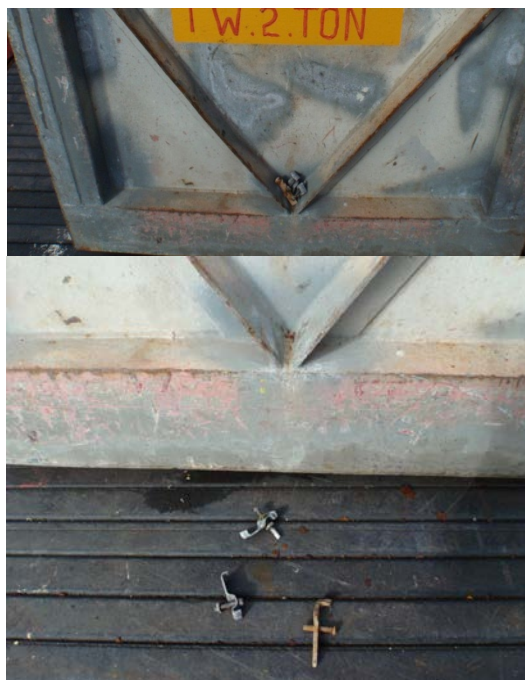
A Platform Supply Vessel (PSV) was receiving back loaded containers from an offshore platform. A garbage skip was in the process of being transferred when 3 grating clamps fell to the deck of the PSV. The clamps had been resting in the lower framing on the end of the skip (see photo below).

- Cargo sitting for a period on a deck of the platform was used as a means for resting tools.
- Prior to the lift being sent to the PSV, it was not thoroughly inspected by a competent person to ensure no potential for dropped objects.

Figure 1 & 2: Clamps positioned before (re-enactment) and after the execution of lift.

- (1) Items which are requiring to be transported by any means are NOT to be used to rest tools or equipment on.
- (2) A competent person to thoroughly inspect every lift PRIOR to lifting to ensure no potential dropped objects exist.
- (3) Communications between facility and PSV to ensure prior to any cargo operations that all equipment has been checked for potential dropped objects. This includes cargo being discharged from the PSV.
