# Marine Safety Flash

## A13-06 (15<sup>th</sup> March)

### Elbow injury while traversing gangway

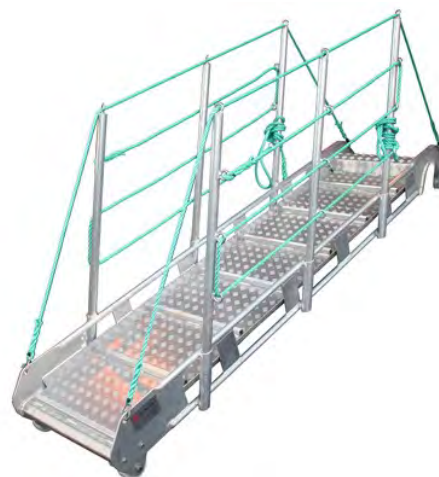
During crew change of an offshore support vessel (OSV) alongside a quay, a crew member was traversing up a gangway with luggage when their elbow struck the side stanchions.

**Figure 1: Gangway similar to the one struck by injured person.**

- Gangway was shore-side provided equipment
- The gangway did not comply with the provisions contained in SOLAS regulation 3-9 ch2-1, IMO circular MSC1/1331 or Marine Orders part 21 app 9 in terms of minimum dimensions.
  - These regulations require the minimum breadth of a gangway to be 600mm
  - The gangway in question was measured to be 510mm wide

- Non-compliant gangways to be taken out of service and replaced with compliant equipment
- Reduce the size or profile of luggage, or look into alternative means of loading luggage on board. E.g. Ships crane with basket or cargo net.
