Marine Safety Flash

A13-08 (15th March)

Stand Clear Of Snap Back Zones

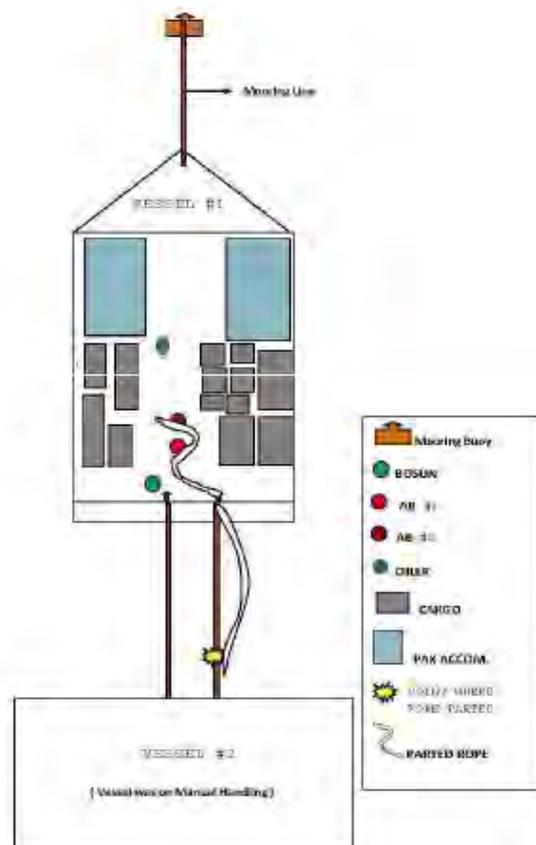
Two (2) offshore supply vessels had just completed a stern-to-stern transfer of brine. Vessel #1 (the smaller vessel) was moored to a buoy with engines shut down and Vessel #2 (the larger vessel) was manually manoeuvring. Vessel #1 secured Vessel #2's mooring lines on their raised tow pins. After the hoses were retrieved, the Master of Vessel #1 instructed the deck hands to cast off the lines. Two (2) ABs were on deck coiling the transfer hose and the Bosun had moved closer to the stern to attach a messenger line for a controlled release. Vessel #2 requested Vessel #1's deck crew to cast off lines, moving slowly astern to release the weight on the lines. However, to check stern mover, Vessel #2 then engaged its engines slightly ahead. The lines came under tension and one line parted and snapped back striking both AB's on the deck.

- (1) Seas were 2-4 ft. with swells that affected the tension on the mooring ropes.
- (2) Vessel #1 was secured to the mooring buoy, with the Vessel #2 manually manoeuvring.
- (3) The mooring ropes were secured on the tow pins.
- (4) The JSA did not identify the Snap Back Zones.
- (5) There was inadequate supervision on the deck of Vessel #2 providing the bridge team with direction.
- (6) Crew members from both vessels failed to use STOP WORK in a potentially hazardous location.

ROOT CAUSE: Lack of supervision, inadequate JSA and failure to use STOP WORK.

Figure 1: Diagram of the incident and position of injured parties.

- (1) Vessels should use DP Mode for Vessel-to-Vessel transfer operations whenever possible.
- (2) Use only mooring bits to make fast.
- (3) A smaller vessel should always make fast to a larger vessel.
- (4) A thorough pre-job Risk Assessments / Job Safety Analysis must be conducted with all parties involved participating. Adequate supervision and hazard awareness must be included.
- (5) Stop Work must be promptly utilized when conditions change or hazards are presented that make operations unsafe.
