Marine Safety Flash

A14-10 (30th June)

Injured Party struck by tugger wire assembly

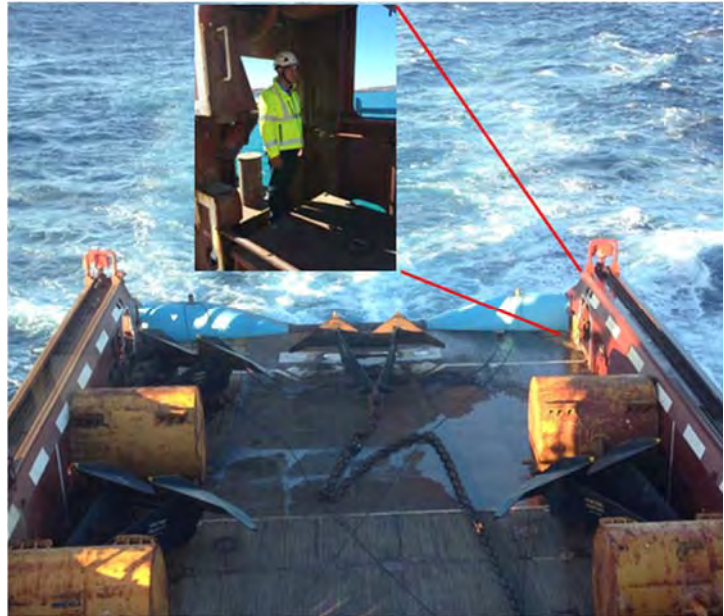
Worker position behind cargo barrier in area considered a 'safe haven'.
Note: Configuration of equipment on vessel deck is not the same as when the incident occurred.

IP was positioned in port aft side next to the capstan in an area considered to be a 'safe haven', and considered to be out of the line-of-fire and recoil area for this operation.

1. Be aware of what a “**Safe Haven**” means. Crash rails are not to be considered as safe havens.
2. Ensure a clear deck policy means no one within a snap back zone. When any wire is under tension on the deck, no personnel are permitted to be either in the crash rail or aft of the tugger winches.

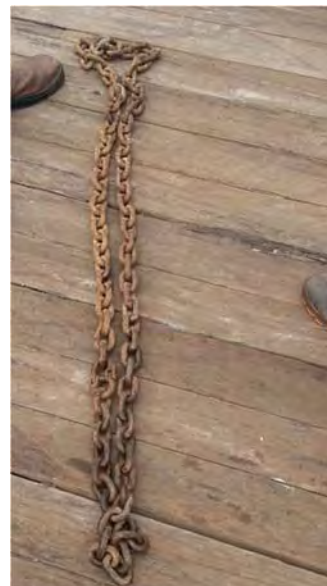
Photograph of chain sling similar to item which parted and was lost overboard.
