Marine Safety Flash

A14-15 (15th September)

Soft tissue injury to hand

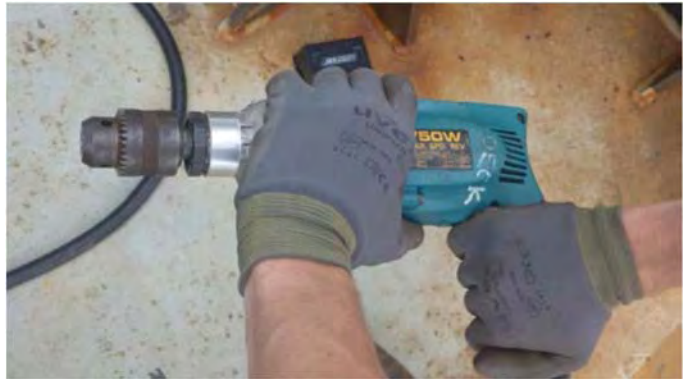
An Integrated Rating sustained a soft tissue injury to their right hand whilst drilling a hole in a 20mm thick mooring winch cheek plate. Whilst completing the final hole, the drill grabbed and forced the IP's wrist into another part of the drum injuring his right hand.

Hand Positioning whilst drilling hole

- Is work positioning correct for the task?
- Is the correct tool being used for the task?
- Has a Step back 5x5 Situational Risk awareness process been used to identify and control all hazards prior to commencing task?
