Marine Safety Flash

A14-16 (15th October)

Tagline Entanglement

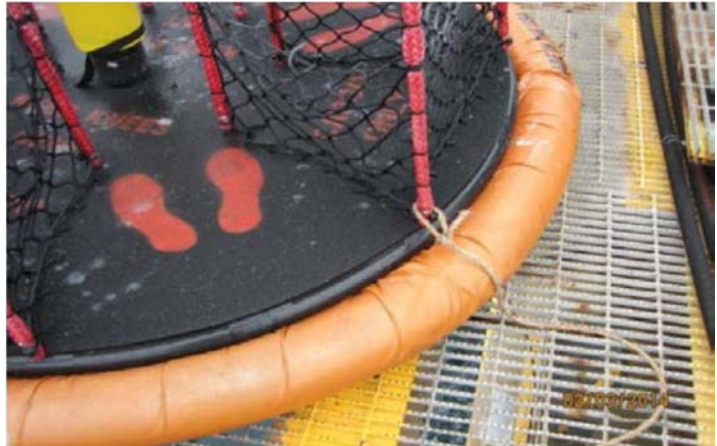
At the conclusion of the second of two personnel lifts, a 1/4" manila rope tag line that was attached to the basket became entangled around the lower left leg of the vessel's rigger as the basket was being raised. The rigger was lifted approximately 15 feet in the air before SWA was called. He was lowered safely back to the deck without injury.

1/4" manila rope tag line that became entangled and wrapped around the riggers leg, causing him to be lifted 15' in the air

- Use a semi rigid, tangle-free tag line as recommended by the personnel basket manufacturer.
- Include tag line hazards on lifting and rigging JSAs and reinforce their use during pre-job meetings.
- Stay alert and focused during personnel transfer operations.
- Don't loop tag line around wrists, or other parts of the body.
- Keep all sections of the line, including slack, in front of the body, between the handler and the load.
- Don't retrieve taglines by going under load.

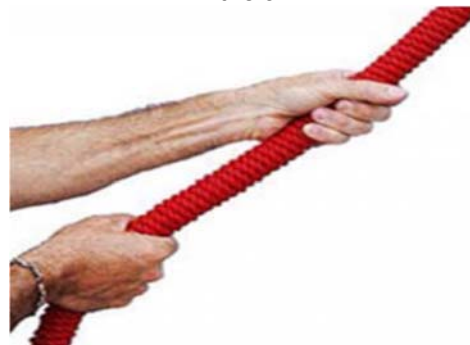
Personnel basket manufacturer's recommended tangle-free tag line (was not in use)
