Marine Safety Flash

A15-05 (15th March)

Ship's stores crane block fell to dock

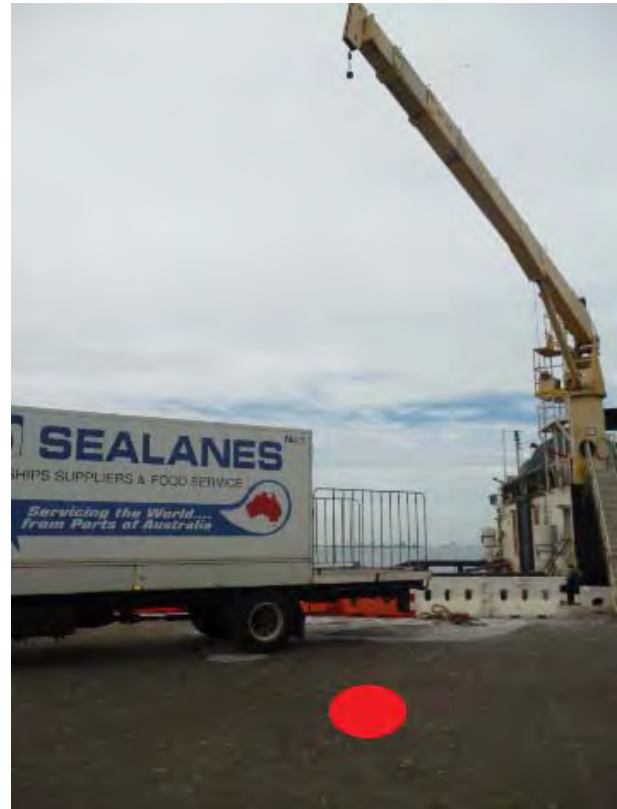
The result was the crane hoist wire rope parted and the block fell to the dock.

Location of dropped block

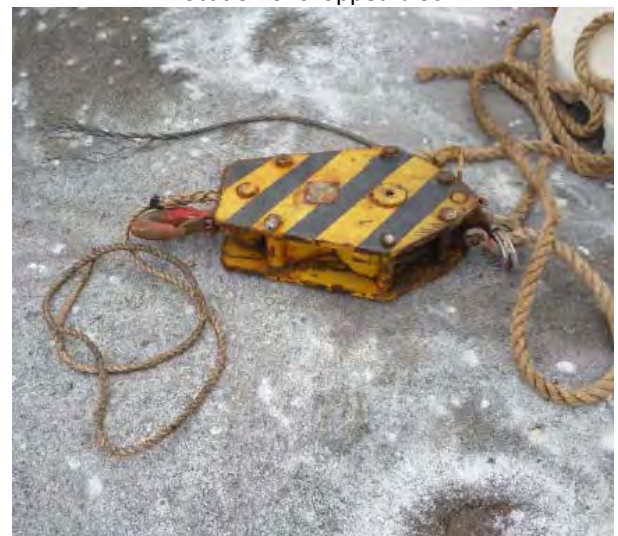
Whilst bringing a ship's deck crane into position to load stores, the boom of the crane was extended causing the crane block to come into contact with the crane head sheave which placed excessive tension on the wire.

Crane block showing parted wire

- Have pre-start checks been completed?
- Are safety devices and systems operational?
- Is there opportunity for safety systems to be bypassed or overridden?
- Are operators trained, competent and authorised?
- Are personnel out of line of fire?
