# Marine Safety Flash

## A15-12 (15<sup>th</sup> July)

### Broken Tow Line

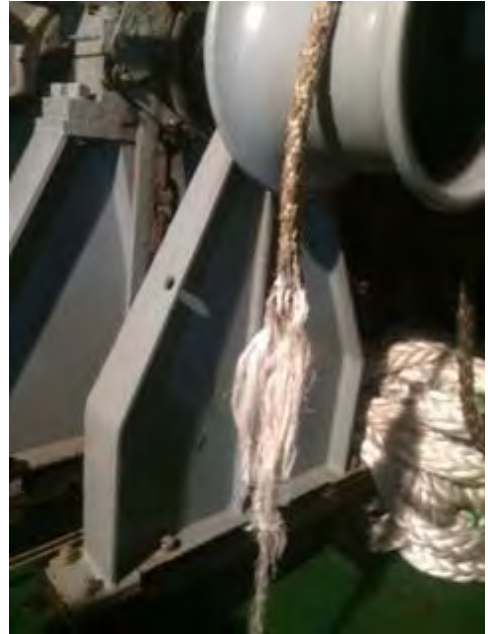
On passing the breakwater the ship's speed was about 4.5 knots, the Pilot requested the tug to "lay back" alongside at one-quarter power, this request was acknowledged by the Master. On adjusting the azimuth pods to about five degrees aft thrust, progressing towards the requested one-quarter power, the line to the ship then fell into the water from the bow whilst still making forward head way.

On recovery of the line, it was found that the Messenger had parted. It is assumed that the Messenger was belayed in some fashion to the ship's bitts. Due to the height difference between the tug and the ship there was no way, as is normally the case, to visually observe the Grommet placed on the ship's bitts once passed through the panama lead.

Where possible, visually observe the Grommet being placed on the ship's bitts. This is the first instance known in this company of the Messenger being attached to the ship's bitts. The Harbour Master informed the ship of the instance and requested that the crew be aware of the correct tug connection procedures.
