Marine Safety Flash

A15-14 (15th July)

Failed Wire Grommet

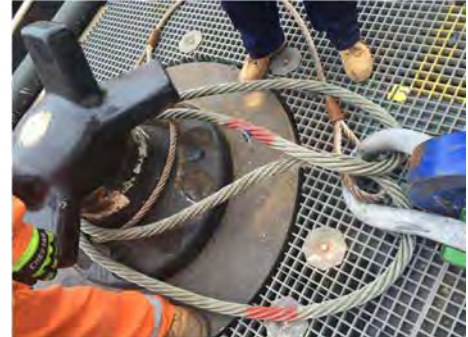
The wire grommet, connecting the Shore Tensioning Unit (STU) sheave block to the bollard, parted causing the block to move towards the vessel.

Safety Sling and Wire Grommet arrangement

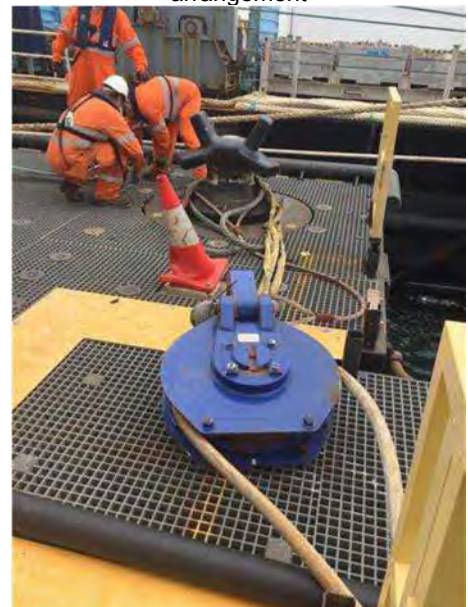
The block was arrested by the safety sling in place and came to rest on a designated access way. No personnel were in the vicinity of the mooring dolphin/access way at the time of grommet failure.

Sheave block came to rest on Walkway

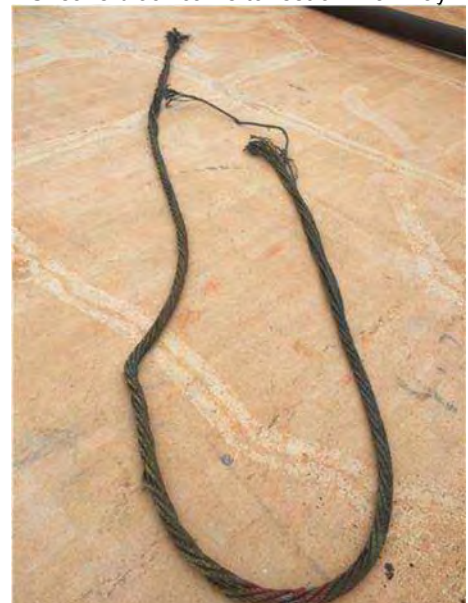
Failed Wire Grommet

- Works ceased, area made safe
- Company and Stake holders notified
- STU hold back pressure released
- Wire Grommet replaced

- Design
- Access/ egress to restricted area
- Suitability of hardware
- SIMOPS
