Marine Safety Flash

A15-16 (15th July)

Tow Pins Residual Pressure

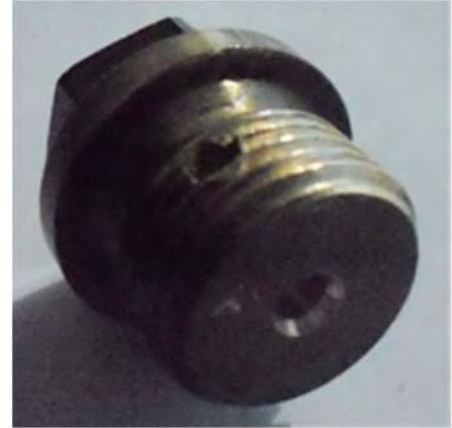
The second incident occurred when an IR attempted to remove the vent plug, the residual pressure within the tow pin blasted the plug out, striking his wrist and sending the plug and allen key overboard. The impact resulted in a soft tissue injury and a sprained wrist

Due to their design, one can never be 100% certain that there is no residual pressure remaining within the tow pin (even after a period a month or more). This is a closed system, and there are times when pressure can build up within the lubrication chamber. There is no indication of any pressure and pressure is only released once the vent plug is removed.

In order to mitigate the stored energy hazard, management have consulted with the manufacturer and engineered a solution by modifying the vent plug on the tow pin. The modification allows pressure to be vented, prior to the complete removal of the plug from the tow pin. Feedback on the modified vent plug has been good, so now all vessels in their fleet have been asked to complete this modification to the towing pin's vent plugs.

The modification involves drilling a hole, half way through, in the centre of the base of the plug and then another hole that meets it at 90° (as pictured).
