Marine Safety Flash

A15-17 (15th August)

Dropped Wear Plate from Crane

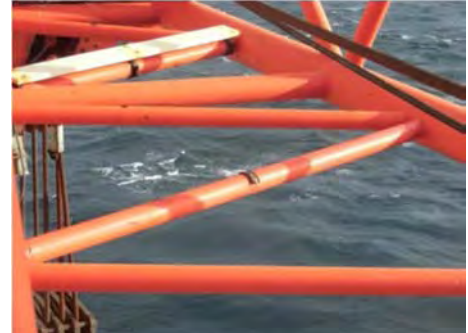
1. Audit and Inspection - Assessment or Audit Failed to uncover inadequacies: The Contractor Daily and Weekly crane inspection checklists and maintenance programme did not include wear plates and brackets as items to be inspected and maintained.
2. Audit and Inspection – Assessment or Audit Failed to uncover inadequacies: The Audit and Inspection Plan and pre-mobilisation checklist did not include criteria / requirements to assess crane condition or evaluate inspection and maintenance records for critical areas (this would include crane boom and fixings).

Original position of Teflon wear plate on boom lacing in boom tip section

1. Contractor to immediately inspect all boom lacing wear plates and fixings and as appropriate, replace on all vessel cranes. It is further recommended that a secondary fitting (e.g. lanyard) be considered to prevent object falling in the event that the primary fixings fail.
2. Incident Lessons Learned to be shared across Contractor fleet and relevant Owners Team Assets.
3. Contractor to revise their crane inspection checklists and maintenance programme for the vessel and ensure implementation across other Pipelay vessels fitted with cranes.
4. Review to be undertaken of existing Owners Team pre-mobilisation documentation to determine specific details of the inspection checks for boom lacing wear plates and associated fixings. Subject to this outcome, consideration should be given to engaging a Third party Crane Specialist (SME) to address this issue during pre-mobilisation inspections.

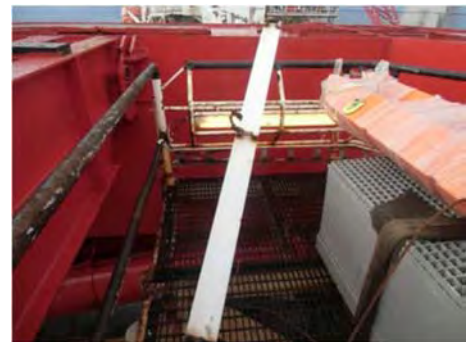
During crane operations on top of the firing line, a Teflon wear plate (2.5m x 450mm, weight 14kg) fell approximately 40m from the Special Purpose Crane (SPC). The falling object struck the IP across the back of the head, right side of face and neck, causing an abrasion and swelling.

Fallen wear plate on C Deck adjacent to the load landing area.
