# Marine Safety Flash

## A15-18 (15<sup>th</sup> August)

### IP Loses Footing on Unsecured Floor Grating

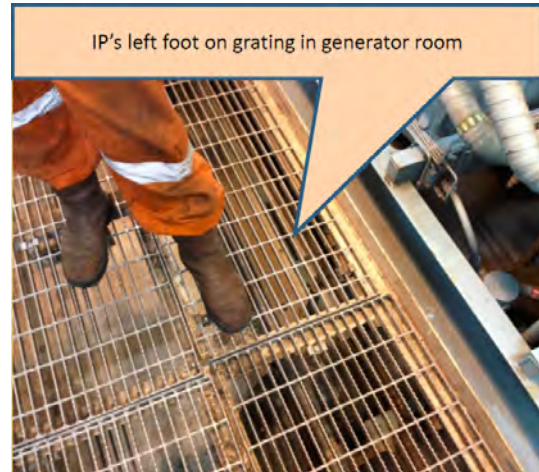
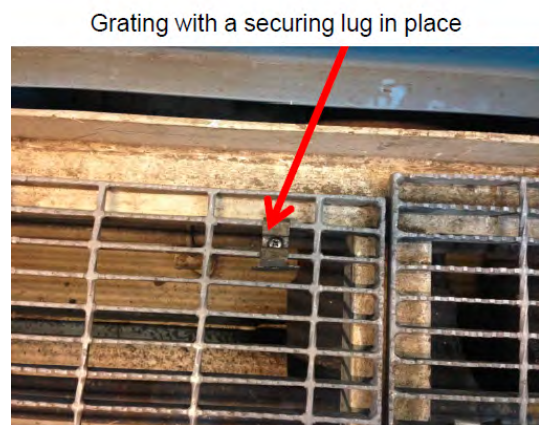
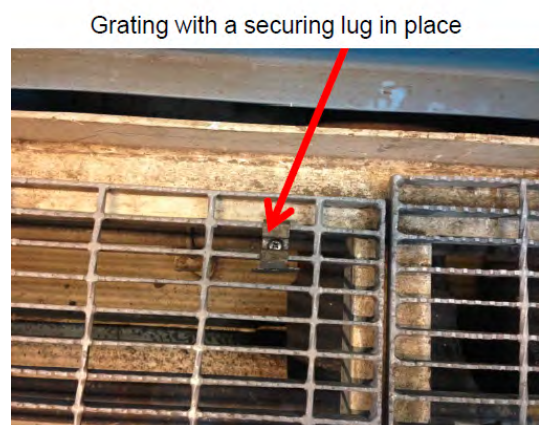
IP was draining the settling and day tanks in the generator room when the unsecured deck grating plate they were standing on shifted between the deck support beams.

The IP's left leg dropped into the bilge below, resulting in abrasions to the IP's left calf and left forearm.

- IP assessed by onboard medic - first aid treatment delivered
- Grating checked and secured in all work areas
- IP returned to work.

1. Maintain safe access to walkways
2. Ensure identified hazards are addressed and made safe.
3. Ensure Injury Management protocols are adhered to at all times.
4. Ensure available safety devices are utilised to maintain a safe working environment at all times.
