# Marine Safety Flash

## A15-19 (15<sup>th</sup> August)

### Securing Plate Dropped from Main Hoist to Boat

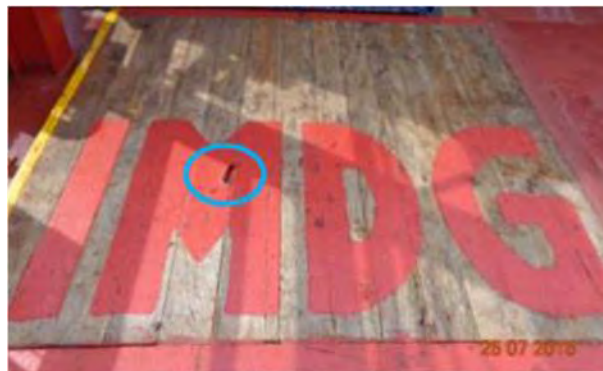
Upon inspection it was found that a securing plate for the “VEE” Shaped Bumper Frame of the main block and its two securing bolts were missing. The plate is 15” long X 4” wide x 1” thick of steel and weighs 7.75kg’s. After delivering the DG Manifest to the boat, the plate fell 240’ from the main block landing on the port stern area of the deck, bouncing to the stbd side hitting the stbd wall and finally bouncing off the centre stern roller and into the ocean. There were no injuries to any personnel.

Point on impact on vessel Deck

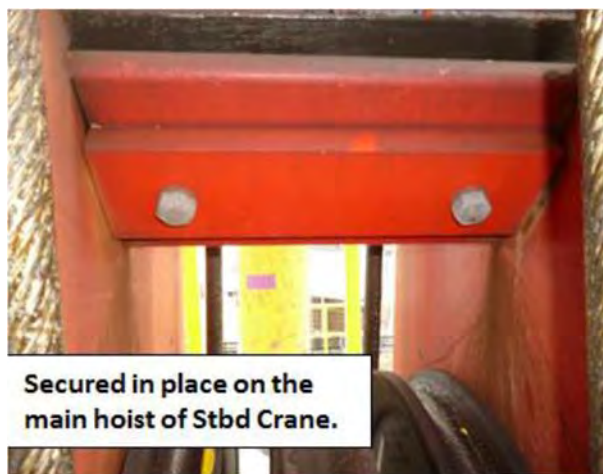
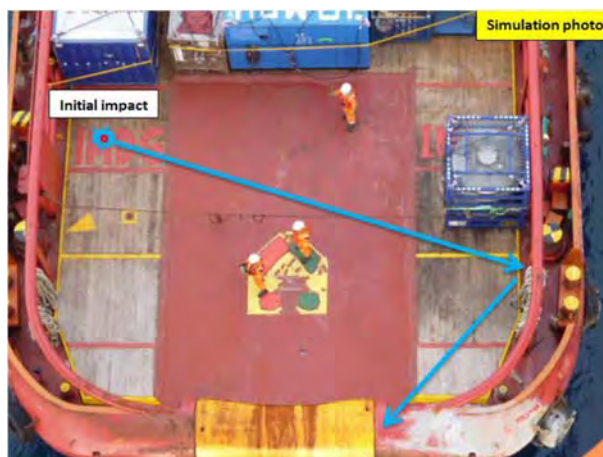
Path of Projectile from initial point of impact
