# Marine Safety Flash

## A15-22 (15<sup>th</sup> September)

### LSA Equipment Damage

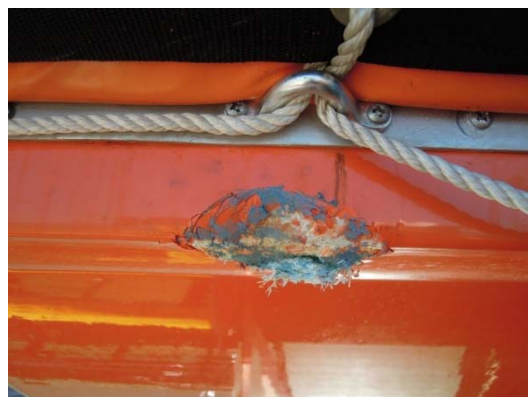
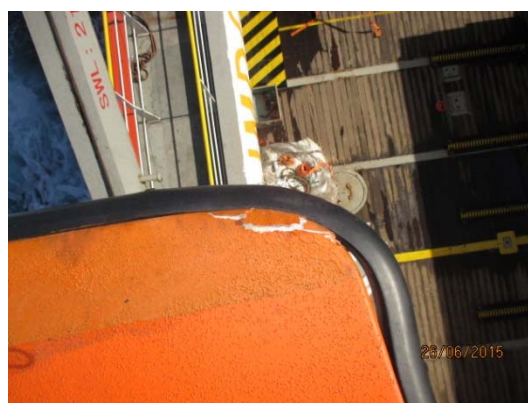
During slewing of davit outboard, the rescue craft (RC) came away from its davit cradle. The RC bow contacted a fixed handrail stanchion of the vessel. Then the RC swung back in and struck its stern against the cradle. The impact resulted in an 80mm scrape forward & two 40mm scrapes aft through the gelcoat and into the fibreglass on the RCs bottom.

Coxswain attempting to manoeuvre the RC alongside backed the port corner of the boat into the ships side causing crushing of the top edge of the sponson.

Damage to the Rescue Craft

- Review and / or revise Safe Operating Procedure (SOP) as well as JSA for Rescue Craft Operations – ALL associated risks to be identified and mitigation put in place in advance.
- Experienced crew member to command the RC during drills and on board training of other crew members.
- All crew members MUST strictly adhere to the on board SOP and JSA during drills and training.
- Deviation from Operating Procedures should be avoided at all times during on board operations and drills.
- Appropriate PPE MUST be worn during shipboard drills and training without fail.
