Marine Safety Flash

A15-28 (15th December)

Dropped Base Frame of the Lubricator Pump

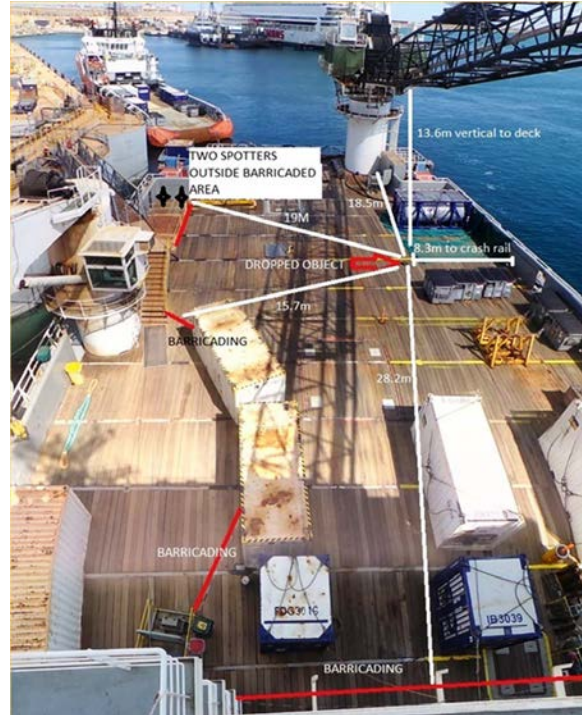
During routine maintenance of vessel's crane, the base frame of a pneumatic grease lubricator pump fell 13.6 metres from the boom walkway to the barricaded exclusion zone on the main deck below.

Location of dropped object

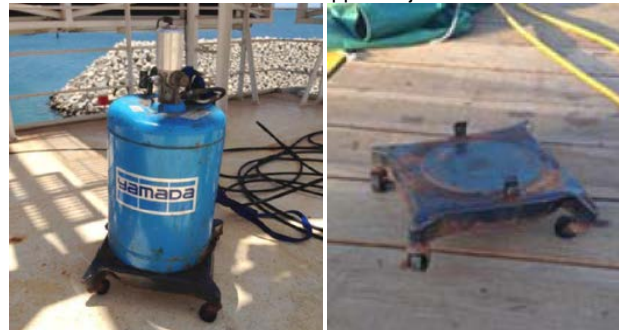
The base frame of the lubricator pump, which is secured by two clamping nuts, became detached from the unit's cabinet whilst being carried along the boom walkway. This allowed the base to fall to the walkway and then to the deck. No personnel (including spotters) were at risk of contact with the falling object because the exclusion zone was barricaded in accordance with procedure.

Grease lubricator pump and base frame

1. Securing arrangements for equipment used at heights shall be fail safe to mitigate risk of dropped object(s).
2. Risk Assessments tools (e.g. 5x5's, JHA's) should be used to identify specific dropped object potentials.
3. Equipment to be used at heights should be evaluated as being fit for purpose and suitable alternatives used if risks associated with dropped objects can be further mitigated.
