Marine Safety Flash

A15-31 (15th December)

Mooring Line Release

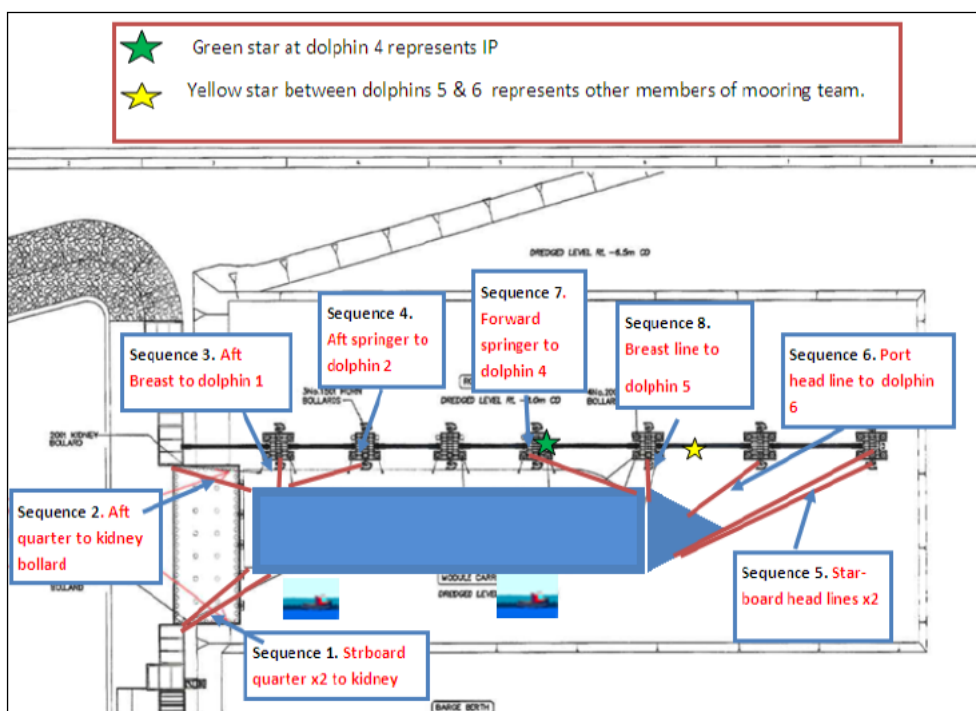
Whilst de-berthing the pilot noticed that one of the linesman had released the forward spring line out of sequence with the agreed plan, causing the pilot to re assess the release sequence plan for the vessel. This in turn had the potential to place the IP in line of fire.

- The de-berthing was paused until pilot re-assessed situation.
- Pilot readjusted tasks to allow for new sequence of line release.

1. Following the plan agreed by all parties.
2. Following procedures that are in place.
3. Situational awareness - Potential Line of Fire.
