# Marine Safety Flash

## A16-01 (11<sup>th</sup> January 2016)

### Near miss collision with moored barge

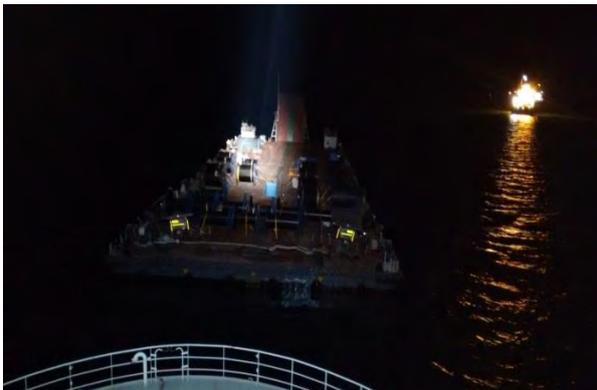
Fig 1

During anchoring up of a Mobile Offshore Drilling Unit (MODU) rig in confined waters within port limits, a near miss occurred between an unlit moored barge and a vessel. Whilst running out an Anchor at a speed of 1 knot, approximately 465 m out from the MODU, a barge was sighted lying back on its mooring just meters ahead of the AHTS's port bow by a crew member. This was reported to the bridge and was confirmed by the Assistant Officer on Watch (AOOW) who immediately alerted the Officer on Watch (OOW) who was on the aft controls station manoeuvring the ship. The OOW brought the vessel to an immediate stop dropping the rig anchor to the seabed. The Barge was just outside the rigs restricted anchoring zone however was on the run line that the AHTS was required to travel down in order to place the anchor at the extremity of the rig anchoring zone. There was no contact between the AHTS and the Barge and was treated as a near miss event.

AHTS bow picture with unlit barge ahead

- The presence of moorings with vessels moored, just outside the perimeter of the rig anchorage that represents a risk to the rig move and anchor deployment and recovery to be identified in the rig move procedure and subsequent MOC documents.
- Ensure port rules are understood and any risks elements in the rules may pose to an operation are identified in the risk assessment and task planning.
- Re-enforce with all OOW's International Collision Regulations Part B - Steering and Sailing Rules Rule 5. "Every vessel shall at all times maintain a proper look-out by sight and hearing as well as by all available means appropriate in the prevailing circumstances and conditions so as to make a full appraisal of the situation and of the risk of collision."
- When anchor handling in confined or congested waters, consideration for a dedicated lookout and monitoring of RADAR prior to movement.

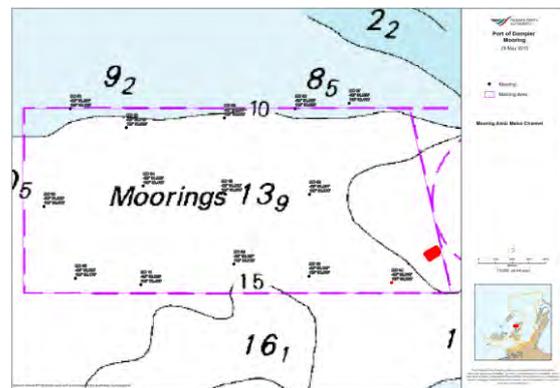
Fig 2

Channel Mooring Area Mooring

position signified by red dot, red square signifies barges approximate position.
