Marine Safety Flash

A16-02 (11th January 2016)

Tugger Wire

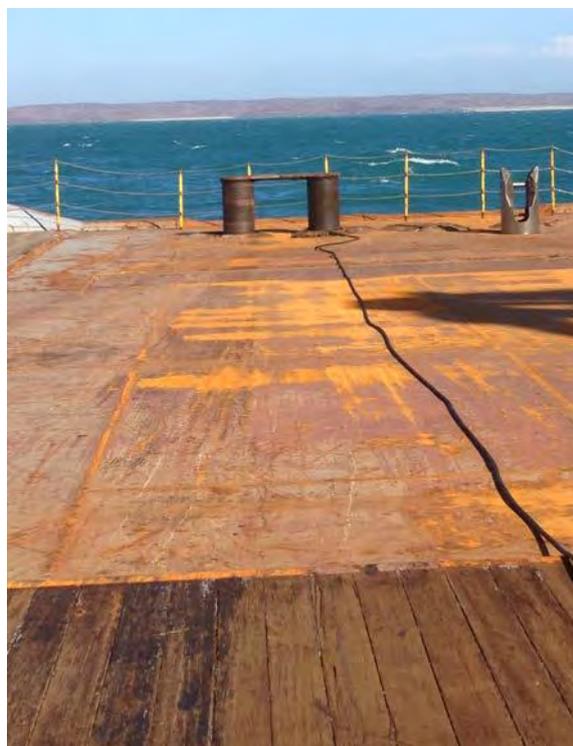
Tugger wire led along the deck and around tow pin

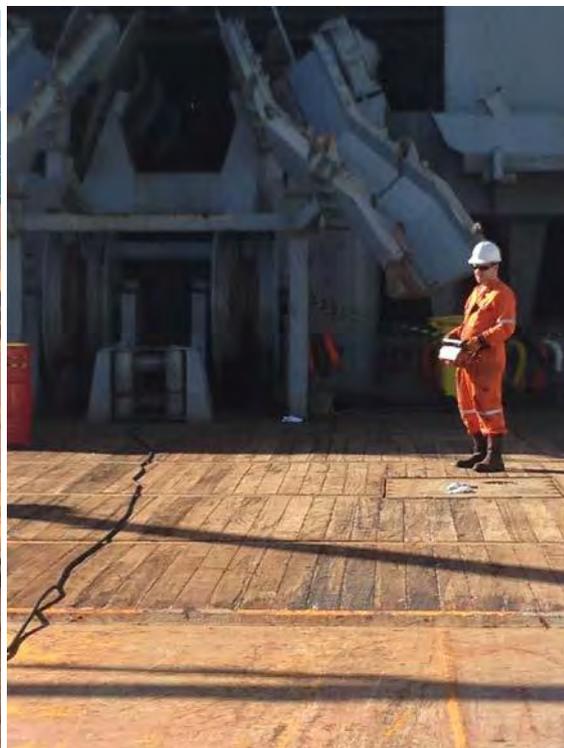
The IP was standing in a position where he could view the end of the wire and winch drum simultaneously.

Approximate position of IP with tugger winch controller

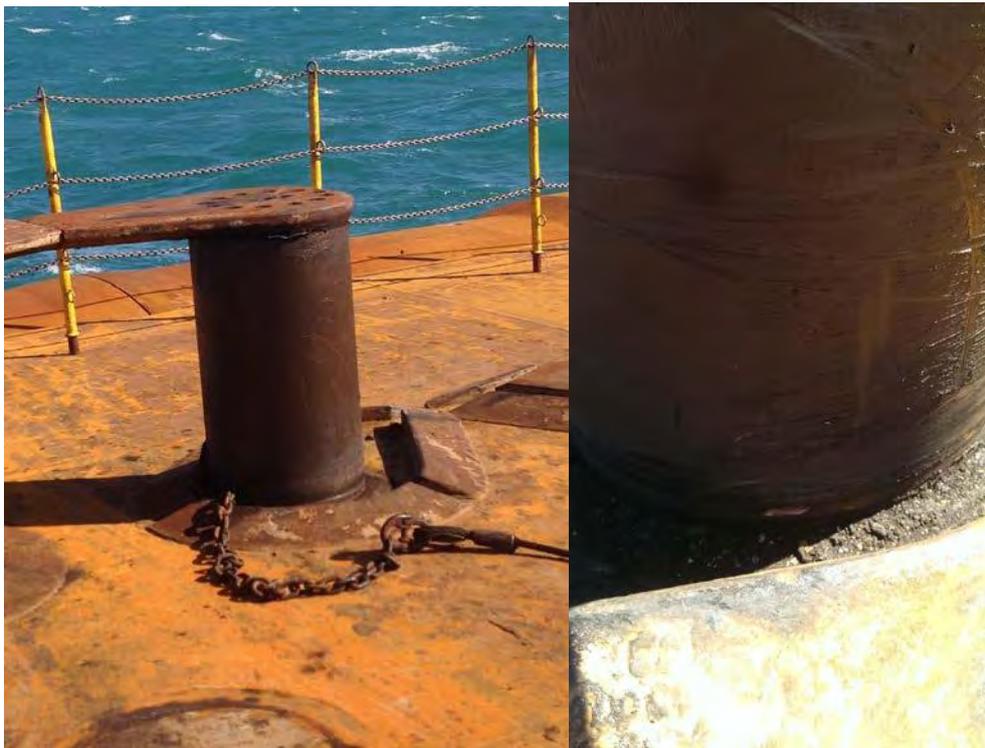
Preliminary investigation has determined that the hook at the end of the tugger wire became trapped in the gap, or annulus, between the raised tow pin and the fairing that surrounds the pin's cap plate when the pin is retracted.

Tugger hook caught in annulus between raised tow pin and fairing

Mark caused by hook caught between raised tow pin and fairing

The tugger wire went tight as the hook jammed momentarily between the base of the raised tow pin and the fairing. That was noticed by the IP and others on deck who reported hearing the wire tightening. The IP released the winch remote control to stop the winch. The witnesses report that the hook freed from where it had been jammed and the wire snapped back travelling forward up the deck at speed.
