Marine Safety Flash

A16-03 (11th January 2016)

Marine Vessel Electrical Incident

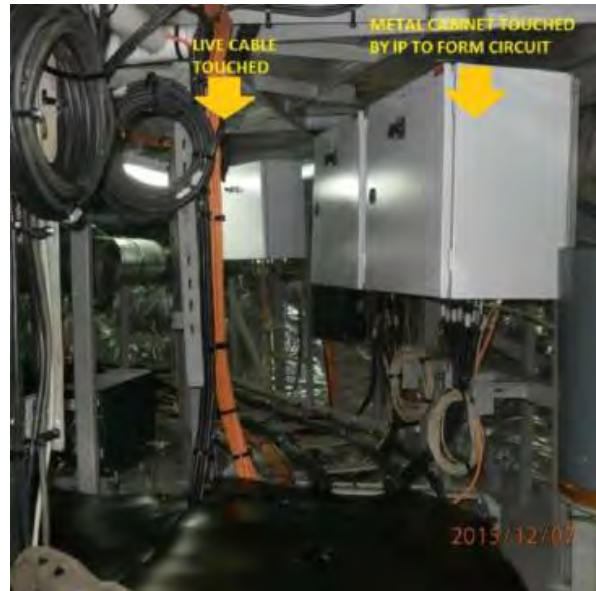
On approaching the power supply for the radar, the second mate used their left hand to stabilise themselves in the vicinity of a surplus coiled cable. The second mate then placed their right hand on a nearby metal cabinet and received a minor electric shock. No injury resulted, however investigations determined that there was no Residual Current Device (RCD) or earth leakage on the power source, therefore there was potential for a fatal injury.

IP place hand on live cable and metal cabinet, forming a circuit

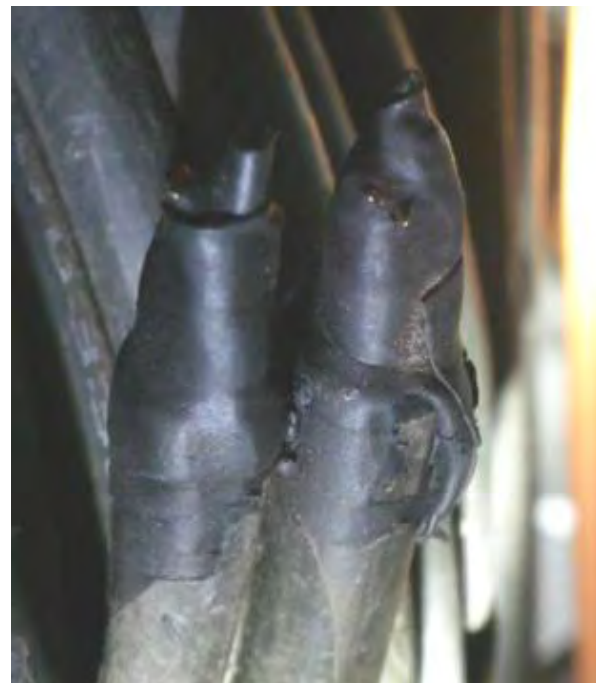
- The surplus coiled cable had been connected at the circuit breaker/board end and had not been isolated correctly at the time of construction.
- The live end of the surplus cable had not been correctly terminated and was not double insulated. Bare wires were exposed.
- It was discovered that it was common practice to install surplus cables in this manner in the country that the vessel was built.
- Class approval and acceptance testing of the vessel did not verify that electrical terminations were in accordance with classification rules/standards.

Copper wires were protruding from electrical tape terminations

- All marine vessels coming under Company Operational Control should have suppliers undertake a detailed electrical inspection prior to mobilising onto the project.
- New Build Vessels which do not have supplier supervision in shipyards should have suppliers undertake a detailed electrical inspection prior to mobilising onto the project.
- All surplus/spare cables should be isolated and tagged out at the circuit breaker/board.
- Submit a notification to class regarding this incident and the findings of the investigation.
