Marine Safety Flash

A16-06 (5th February 2016)

Twisted knee injury from falling through floor plate

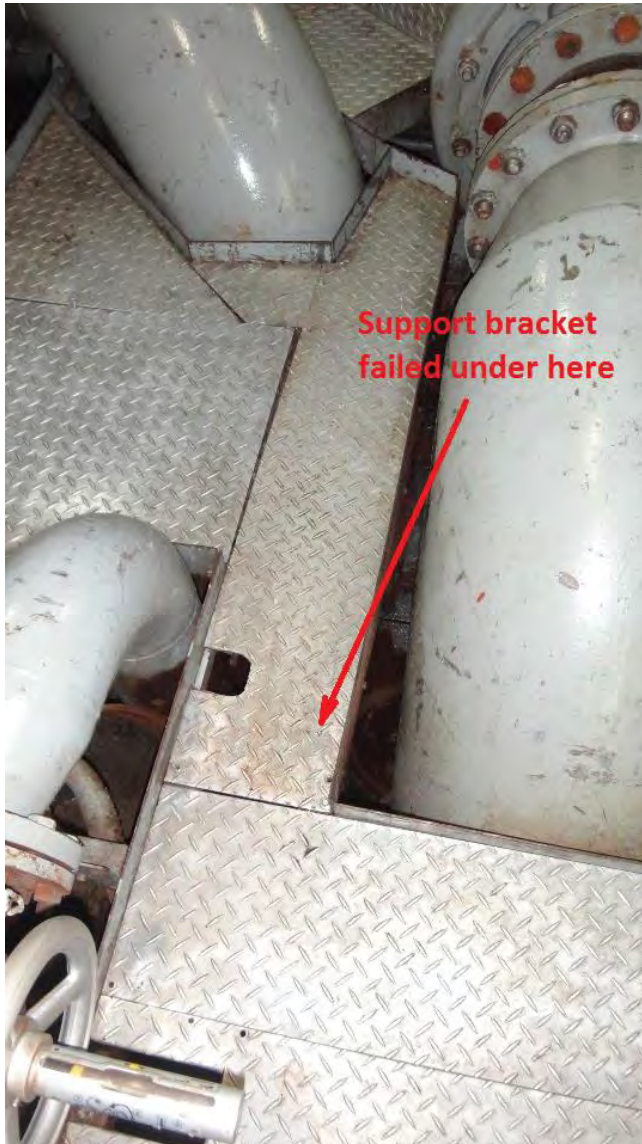
A crewmember was washing down deck plates in the Engine Room in preparation for handover, a routine task. While washing down the floor plates the crewmember was located adjacent to the starboard Fi-Fi pump. The floor support bolting mechanism gave way and the square section bar collapsed. The alloy checker plate that the crewmember was standing on fell through an open gap causing the crewmember to fall into the exposed opening. The crewmember twisted his right knee as a result of the fall.

- The on board investigation found that the structure was last removed during overhaul of FiFi pump 4 months prior to the incident.
- It was noted that the C-section steel of the support frame had aged and was opening up.
- The original design plate securing arrangement had aged.
- Vibration by location of #3 Main Engine may be a contributing factor to the relaxing of securing arrangements in this section.
- Due to the design of the T type connection and the location of the deck plate/structure, it was difficult to visually ascertain that the groove in the nut was sufficiently secured.

- Safety Officers and Safety Representative to discuss this incident with all crew at next Safety Meeting to reinforce the importance of housekeeping. In particular, ensure if structures or plates are removed for maintenance, sufficient re-securing is completed including the floor plate to the supporting structure.
- Engineering team to check all floor plating steelwork in the Engine Room to ensure C-sections are repaired or replaced as required. Where necessary, add new securing plate screws.
- Include in vessel induction and inherent hazard log that if soft foot and/or movement is encountered under foot on any floor plate or walk way, immediate investigation is to be undertaken.
- Include in the weekly hazard rounds to check for any potential soft foot and/or movement on any floor plate or walk way in the engine room.
