# Marine Safety Flash

## A16-07 (8<sup>th</sup> February 2016)

### Blackout due to human error

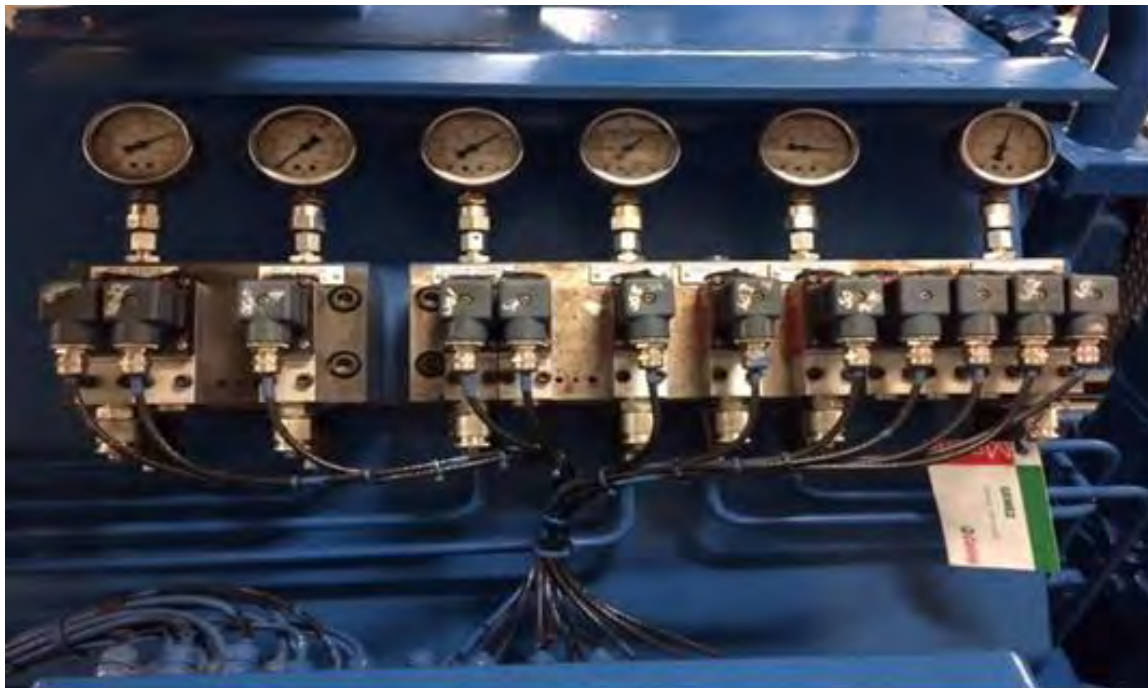
Partial black-out sustained on board, starboard side - Oil sample was taken from wrong sampling point ("clutch supply press.") on starboard main gear, causing a pressure drop, activating the shut-down pressure switch. This caused a short black-out on starboard side, lasting until stand-by generator came online.

Original setup (originally the far right sample tag was the “only” indicator of sample point):

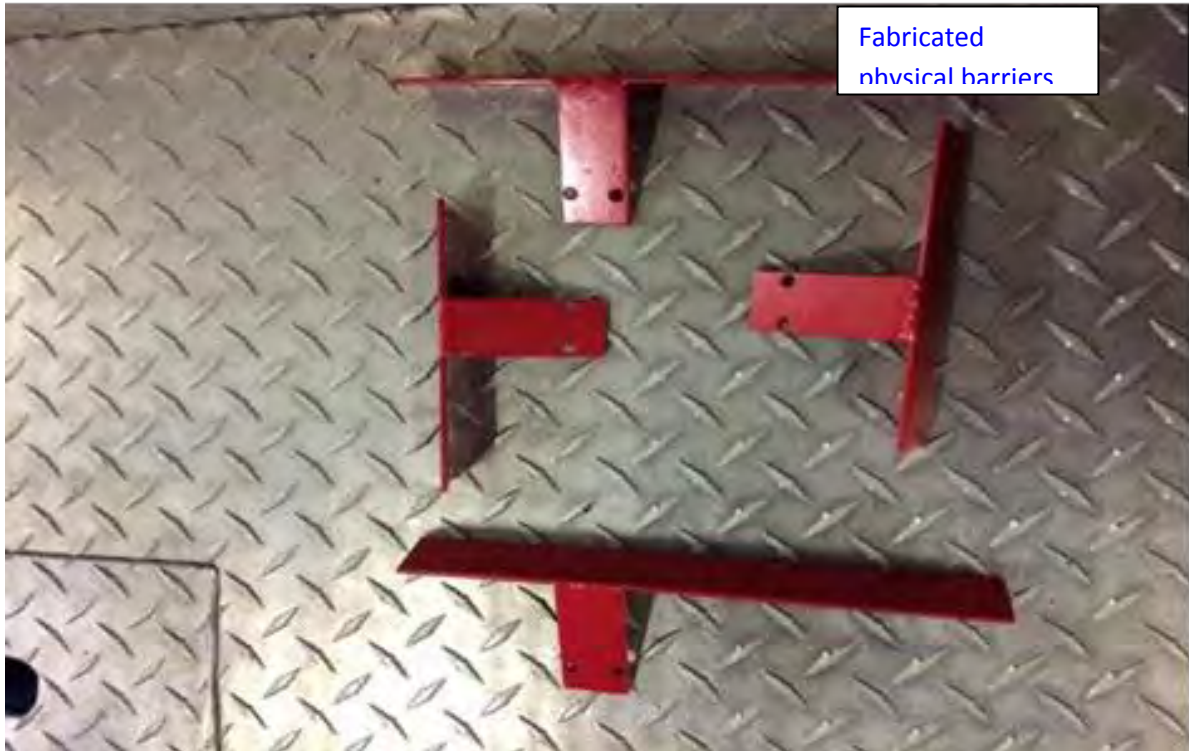
Fabricated  
physical barriers

Consequently, the vessel has proposed a further preventative actions (captured below), an engineering control to prevent reoccurrence.

Fabricate barriers to prevent caps being removed on main gears.

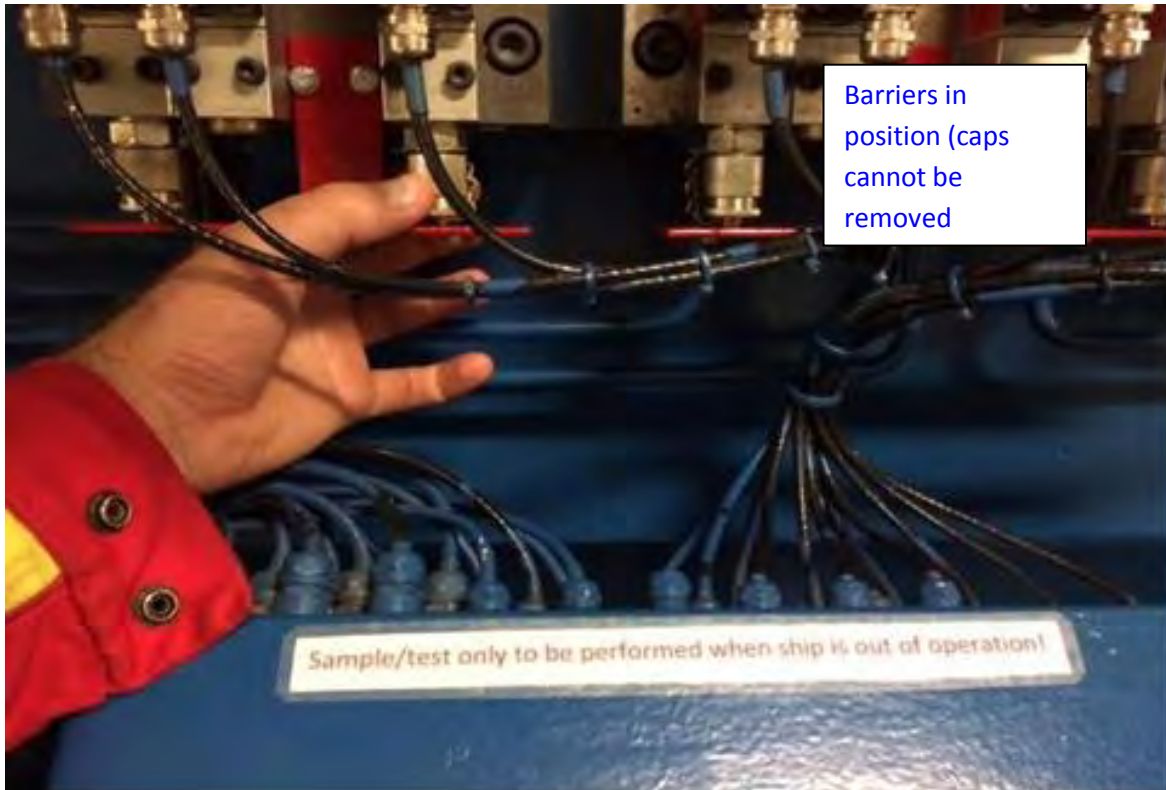
Barriers in position (caps cannot be removed)
