Marine Safety Flash

A16-08 (9th February 2016)

AB hit by a mooring rope

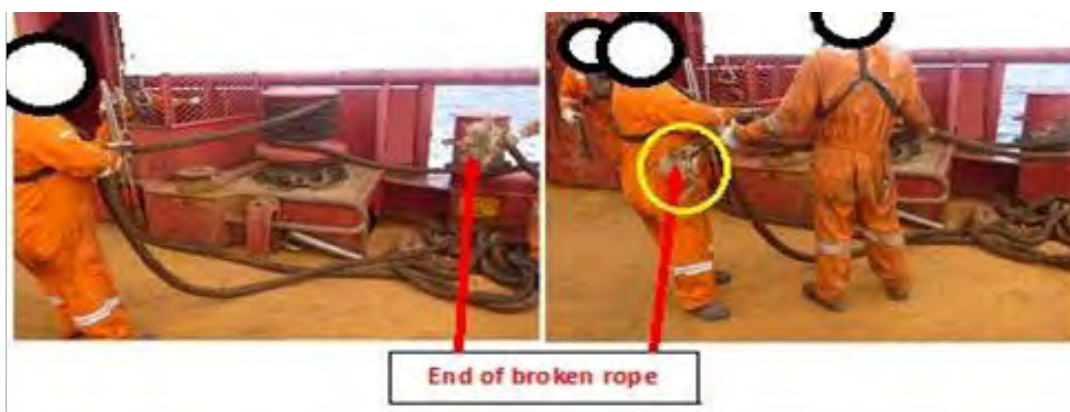
- There was no tension in the rope.
- Rope was in a poor condition.
- Vessel was tied with a single line on both quarters.

- Maintain a satisfactory scheduled maintenance inspection with respect to all wires and ropes on board making sure they are in good conditions prior to use on any task.
- Review the specific Risk Assessment for this task with the crew restating to them the importance of a safe position when handling wires and ropes, we never know where and when it may break.
- Always keep the area clear.
