Marine Safety Flash

A16-09 (29th February)

Embarkation Ladder Failure

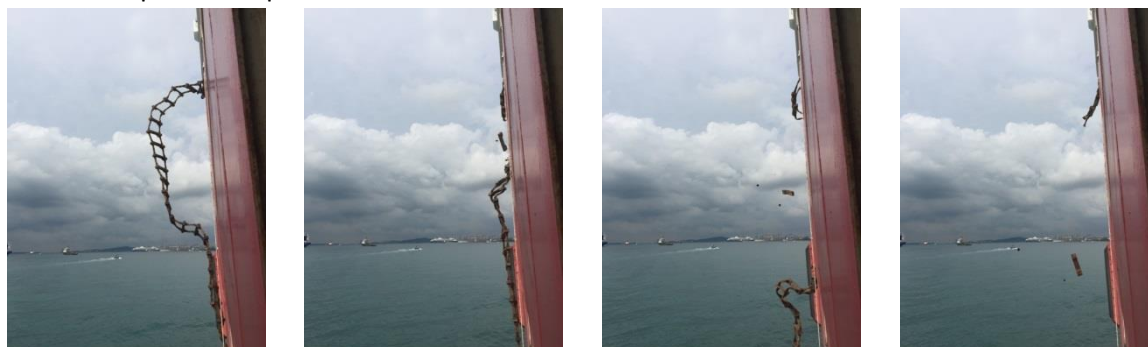
Once the replacement embarkation ladder arrived the Master elected to undertake a drill and deploy the old ladder, rolling it over the side in the manner which would reasonably be expected. As the ladder unfurled and the weight of the ladder came into effect, the ladder parted at the top rung. It had to be retrieved via a small messenger that was attached as a recovery precaution.

Subsequently a test was conducted on the port side ladder and a camera was utilised to capture the result. The picture sequence below shows the results of the trial.

- Recommend conducting inspections of all embarkation ladders and to deploy the ladders over the side at the earliest opportunity (as operations permit).
- A review of the PMS to include a job for deploying the embarkation ladders over the side, to thoroughly inspect and to report any findings.
