# Marine Safety Flash

## A16-11 (11<sup>th</sup> March 2016)

## Mechanical Failure of 10t Stinger During Routine Lift

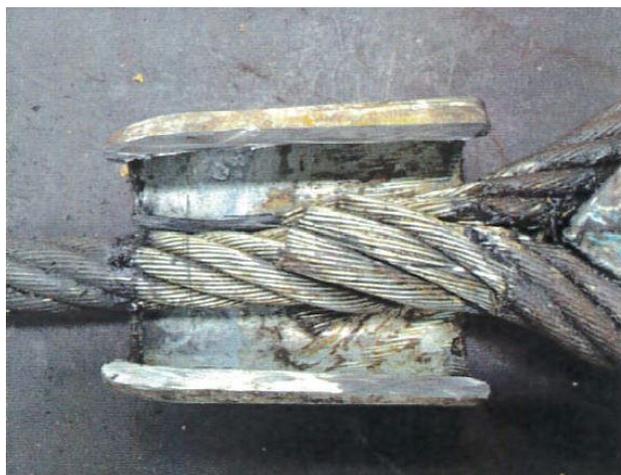
Whilst commencing to take the load of the container the crane's sling failed at the ferrule/ sleeve end nearest to the master link.

The Flemish Eye of the 10t wire rope sling came undone, the loose wire strands slipped through the ferrule/ sleeve and the sling dropped to the deck of the PSV.

- **Inadequate manufacturing procedure, including instruction and Quality Control (QC):**
  - Manufacture of the Flemish eye within the sleeve (ferrule) resulted in wire tails that were estimated to be between 20-40 mm in length, which did not conform with the vendor's manufacturing work instruction,
  - The vendor's work instruction did not provide sufficient guidance to ensure that the wire tails were of equal length after splicing, and
  - Manufacturing and load testing did not involve 2<sup>nd</sup> party QC.

- **Inadequate training and maintenance of training records:**
  - The vendor identified that its operator had not followed its manufacturing work instruction correctly and missed a critical step, which allowed the tails of the Flemish Eye to be too short and unevenly distributed within the ferrule (see image), and
  - The vendor's training matrix did not accurately record all up-to-date training provided to the operator.
- **Inadequate load test:**
  - The load test appeared to have been conducted to an appropriate standard and passed an inadequately manufactured wire rope sling. This was an unexpected outcome for an accredited load test.

1	The manufacturer (vendor) of the wire rope sling was issued with a non-conformance report (NCR), which required them to undertake an investigation to identify causes of the failure and advise corrective actions to prevent a recurrence.
2	An escalated authority to purchase future rigging equipment from the vendor was put in place, pending implementation of their corrective actions.
3	Remaining wire rope slings manufactured by the same manufacturer were quarantined on each Project vessel, pending replacement with independently manufactured, load tested and certified wire ropes. As an interim measure, confidence testing was performed on remaining vendor's slings to 110% of the <i>expected</i> load weight ( <b>not</b> SWL) until affected wire ropes had been replaced.
4	Company's regional procurement departments were requested to engage with suppliers of similar lifting equipment to discuss the information contained within this Safety Flash and request that their suppliers review and demonstrate adequate procedures are documented and implemented to ensure similar instances of non-conformity do not occur.

5	Company Internal Safety Flash was issued globally for information sharing and learning experience.
6	Company inspected the vendor's manufacturing facility. Specifically the QC and competency assurance processes were verified, as well as certification of load testing equipment.

7	Vendor was requested to revise applicable work instructions to provide clearer instruction to operators when forming a Flemish eye to ensure that spliced wire tails were of equivalent length prior to swaging. This change was made to improve the consistency of future wire ropes manufactured by the vendor.
8	Vendor was requested to incorporate adequate 2 <sup>nd</sup> party QC at critical steps during the manufacture and proof testing of Flemish eye wire rope slings. Work instructions to be updated to reflect the critical steps when the verification checks are to be made, e.g. after splicing, swaging and during witnessing of load tests.
9	Vendor was requested to update its Training Matrix to ensure that it adequately reflects all training records relating to the manufacture and testing of wire rope slings
10	The Company shall review the vendor's corrective actions and verify that they have been implemented adequately to prevent a recurring equipment failure
