Marine Safety Flash

A16-14(12th April 2016)

Foot Injury - Steel beam insecure

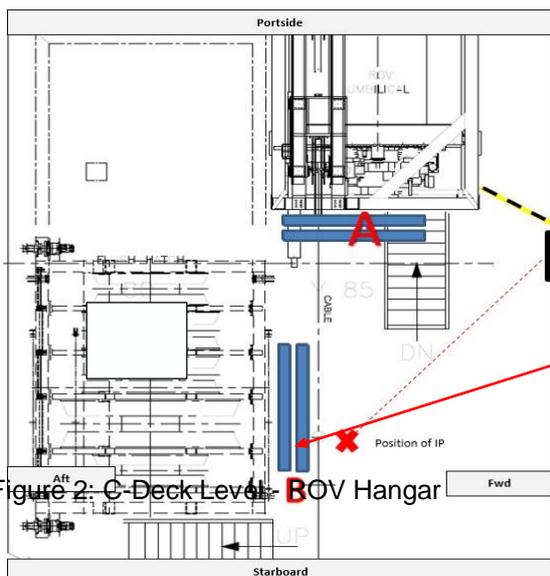
Figure 2: C-Deck Level

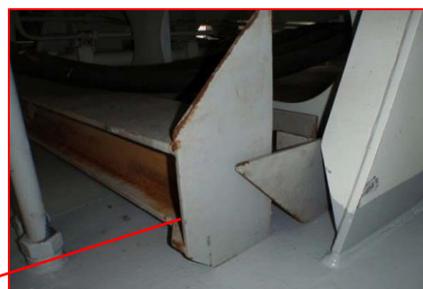
Figure 1: Steel Beam in Upright Position

The deck steel beams were sitting on a raised uneven surface, The combination of the upright placement of the unlashd steel beam, the raised uneven surface and the slight vessel movement rendered it likely that that beam would roll forward. It was not identified in the Risk assessment that the placement of the steel beams presented a hazard.

The worksite was left in an unsecure state; anyone transiting the area was unknowingly exposed to the hazard. The steel beams should not have been unlashd until the beams were required to be relocated, and until the task of moving the steel beams was thoroughly risk assessed.
