# Marine Safety Flash

## A16-16 (13<sup>th</sup> May 2016)

### Near Miss during emergency lowering of FRC

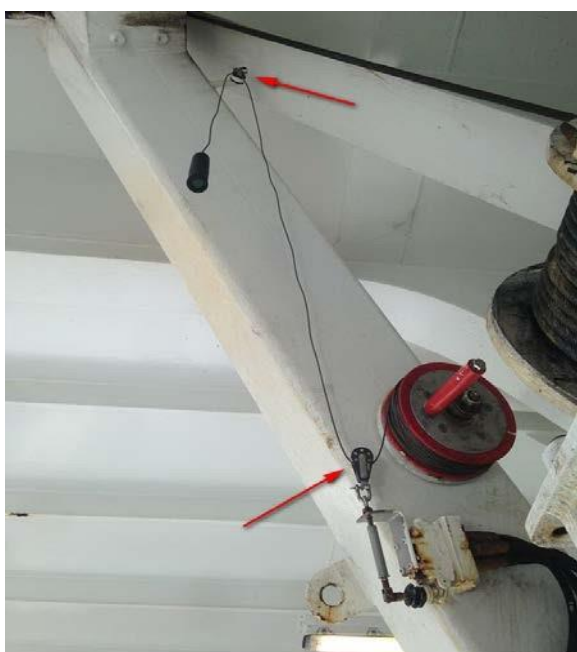
Picture: showing the location of wire pulley with wire

- Lowering wire on the davit jammed in the pulley resulting in uncontrolled emergency lowering

- Visual inspection of emergency lowering system to ensure function and condition.
- Reviewing the scheduled work order in the PMS.

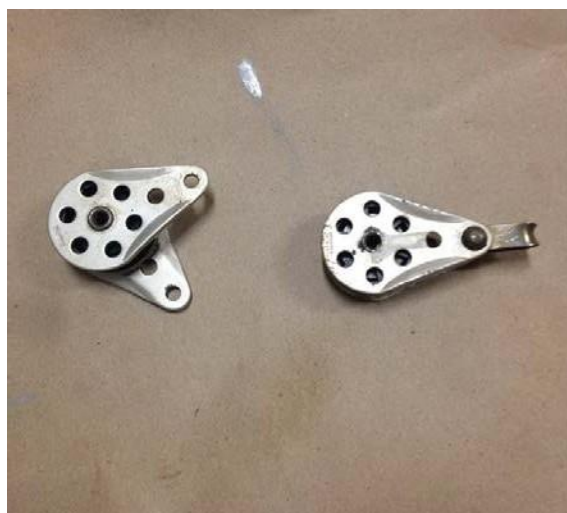
Picture: showing old pulleys
