Marine Safety Flash

A16-22 (15th June)

Cargo shift alongside platform

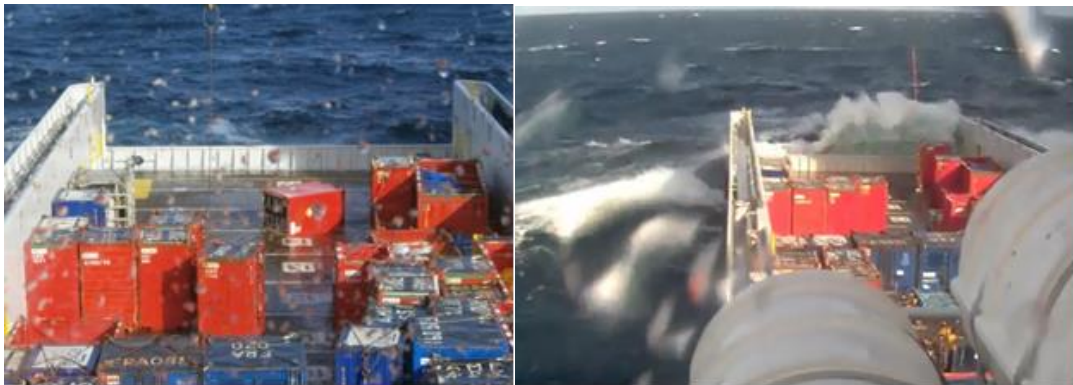
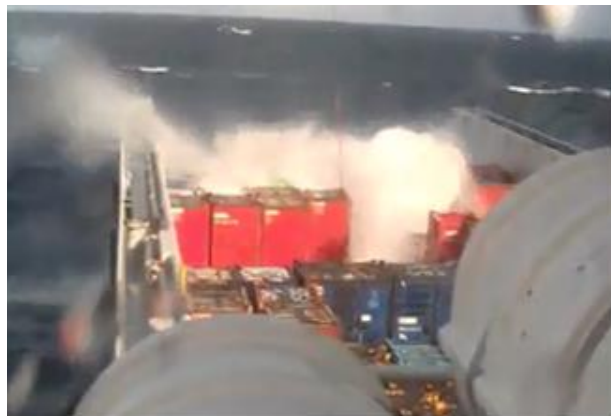
Two mini containers were shifted /capsized by the resultant water on deck.

- Weather conditions at the time of the incident; wind 25 knots, swell 3 meters
- One larger squall (rough wave) hit the stern of the vessel and water flooded the back deck
- Back loaded cargo not yet secured due to ongoing back loading from platform
- The water on deck shifted one container and capsized another mini container

- No people were injured – the deck crew were working at the forward end of the deck at the time of the incident
- No external damage to the containers and no spill
- Vessel designed with a low bulwark
- Reported as a near miss

- The risk of abnormal waves MUST be taken into consideration in the Risk Assessment and Toolbox talk for work with the stern positioned against the weather.
- Stop work policy, by anyone at any time, when in doubt.
- Fit the vessel and sister vessels trading in harsh environment with a higher aft bulwark.

The Company have reviewed and conclude this near miss as a potential fatality case and have started to design a new and higher bulwark to be installed on-board the vessel and sister vessels operating in harsh environments.
