Marine Safety Flash

A16-25 (15th July)

Slip on Engine Room Stairs

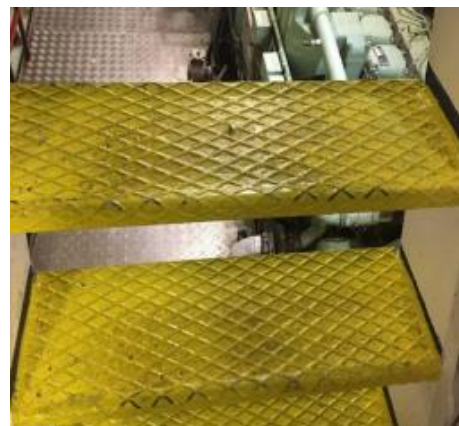
The IP was leaving the engine room after starting the engines and on the way up on the engine room stairs the IP slipped. The IP subsequently grabbed the rail with the right arm to break the fall and consequently jolted the arm and broke the collarbone.

- The stairs leading from the Engine room were very slippery due to a layer of greasy residue on the surfaces of the steps
- The steps were worn on the edges and bare metal was visible
- The steps were coated in yellow gloss
- There was no anti-slip coating applied to the paint

- All step surfaces to be thoroughly cleaned and wiped free of any greasy residue
- Anti-slip paint to be applied to all steps on stairs in Engine room where possible
- Where paint is worn off it must be repainted
- If a supplier has to carry out painting on board the crew and the supplier should meet to discuss the work scope before the paint job start to align requirements such as antiskid paint
- Vessel crews to ensure that regular Safety Area Inspections are performed in order to raise safety awareness. In this case, it is to look for stairs that are dirty, slippery and don't have any antiskid paint applied
