Marine Safety Flash

A16-27 (15th July)

Mooring Rope Fouled the Propeller and Parted

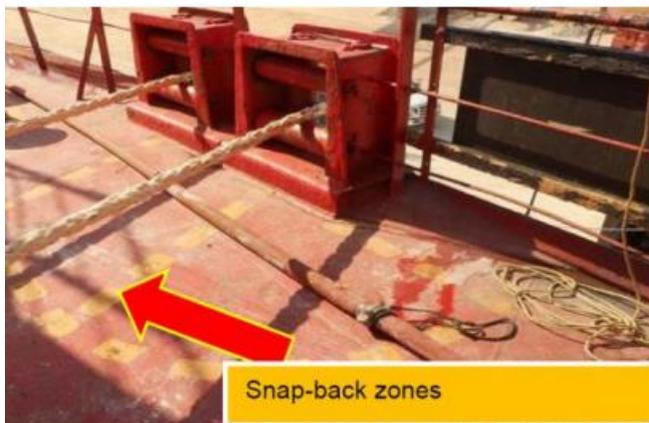
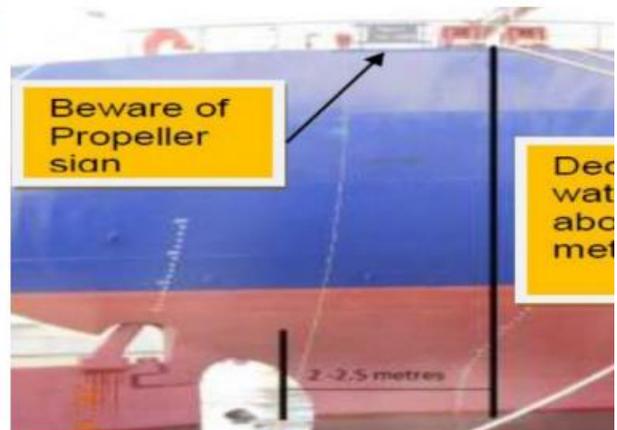
An industry member has reported an incident in which mooring ropes were slacked more than required resulting in a fouled propeller. The incident occurred during berthing operations when the engines were being used. The fouled lines became taut and parted. Fortunately, the recoil was vertically up and down, as the angle was 90 degrees, straight down from the universal leads to the propeller.

The men on stations were standing in the snapback zone, but the near vertical whiplash missed them. The propeller was fouled – there were damaged rope guards and mooring ropes. The vessel had to come off-hire for repairs (fortunately, the stern tube seal was not damaged).

- Crew were using appropriate personal protective equipment (PPE) for the task;
- The immediate cause of the incident was excessive slackening of the ropes when the propeller was turning;

- lack of situational awareness and inadequate understanding of the physical constraints of the ship as the leads being almost directly above the propeller
- ineffective communication between bridge and mooring station

- Bridge issuing orders to slack when the propeller was turning
- Mooring stations obeying the instructions without checking propeller clearance and/or warning the bridge
- Excessive line laid out on deck, which ran out to foul the propeller
- No risk assessment carried out for this mooring operation
- No safety briefing and no toolbox talk carried out
- Inadequate supervision;

- Inadequate understanding of risks involved
- Lack of situational awareness of the surroundings.

- Ensure proper risk assessment carried out for mooring operations;
- Ensure safety briefing and toolbox talk conducted by the person in charge, ensuring that all crew involved in the mooring operation know the risks and actions to prevent incidents;
- Vessel joiners should be properly briefed on ship-specific tasks and constraints;
- Ensure more effective communication between bridge and mooring stations to include warnings as to prevent such incidents;
- Person in charge to take extra precautions and ensure they supervise the area and task properly;
- Re-train crew on hazards and dangers involved in mooring operations;
- Entire mooring deck area should be considered a potential snap-back zone. All crew working on a mooring deck should be made aware of this with clear visible signage.
