Marine Safety Flash

A16-30 (16th August 2016)

Heavily greased wire rope parts resulting in fatality

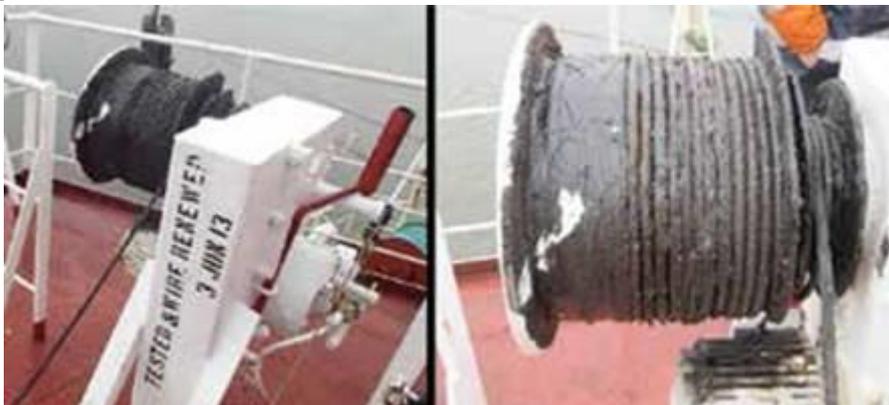
- The wire rope had been rigged incorrectly through the hook, introducing unnecessary stresses.
- The wire rope had a theoretical tensile strength that was approximately 25% less than that recommended by the davit manufacturer.
- Notwithstanding the heavy grease coating, the wire rope was severely corroded at the point of failure.
- The winch automatic shutdown limit switch was found to be defective.

Copious amounts of grease are not always a good sign

- Always rig boat lowering equipment with wire that meets manufacturer's specifications.
- Copious amounts of grease do not ensure that wire ropes are protected from corrosion, and may in fact hide corrosion deficiencies. Corrosion resistance can be increased through the use of galvanized wire in combination with specialty penetrating oils, which have the added benefit of reaching and protecting the wire rope core and keeping the wire clear for proper visual inspection.
- Ensure all limit switches are functional and wires are properly rigged according to manufacturer's specifications.
