Marine Safety Flash

A16-32 (15th September)

Crew member injures back handling raptor link

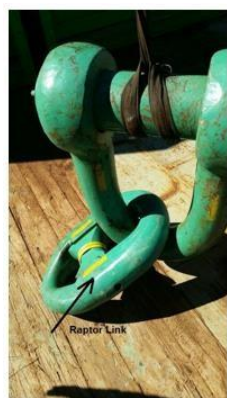
- The lack of an easily manoeuvrable tail chain resulted in the PCP socket being on an awkward angle in the shark jaws for connection to the vessels chain; it also required a connecting link with a larger end and not the kenter shackle normally used. This created additional manual handling risk.

Figure 3 Diagram from the rig move procedure showing chain tail assembly

1. On AHTS vessels, update the Risk Assessment for Receiving PCP from Rig to ensure;
 - a. that Rig has chain tail available
 - b. the lightest, easiest to use, connecting link should be used that meets the MBL required for the job
 - c. Use of cranes or mechanical means to avoid manual handling exposures as far as practical
2. At next Safety Meeting please review with the crew regarding incident notification – reminder that OOW should be notified immediately when an incident occurs as the delay in this circumstance delayed treatment and may have worsened the injury.

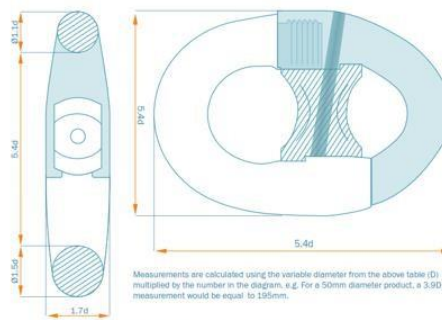
- The decision was made to use a Raptor Link; this was a large, heavy shackle (connecting link, it is not a shackle) that required precise alignment. There were other lighter, easier -to-handle shackles on board that were not used for initial connection, however were used for following connections post incident.

Figure 1 Actual Raptor Link
