Marine Safety Flash

A16-34 (14th September)

Man overboard incident during swing rope transfer

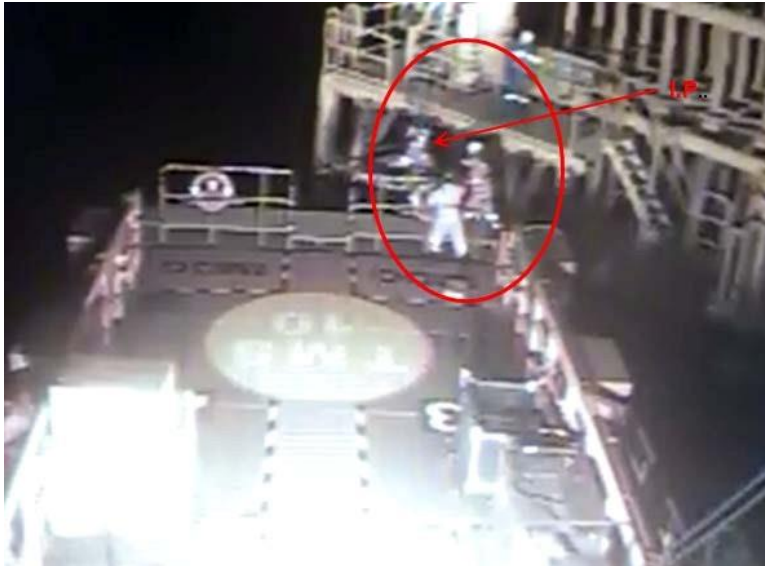
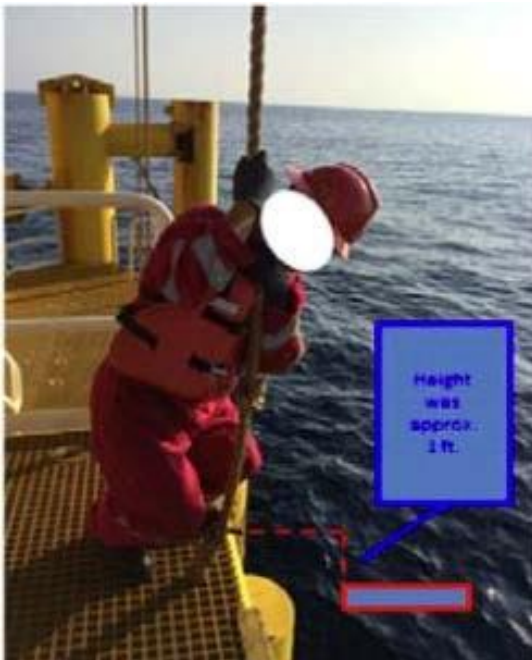
Due to a combination of improper swinging technique and sudden heave movement on the boat, the crew member only partially landed on the landing stage on the crew boat. He released his grip on the swing rope prematurely and fell into the water before the marine crew in attendance could get a hold of him. (Refer to pictures further below which illustrate the position of the IP just prior to falling overboard.

CCTV Footage showing the IP at the point of letting go grip on the swing rope and just prior falling into the water.

1. Marine crew on standby at the boarding stage on the stern deck of crew boats must provide guidance to passengers on the movement on the vessel and actively support to pull passengers across to the landing stage. This provides positive and active intervention.

3. Provide shipboard training to reinforce the roles and responsibilities of the vessel crew stationed at the landing stage. This should include but not limited to crew providing advice on the movement of the vessel and supporting passengers to physically assist them across to the deck of the vessel. Record of completion of this refresher training to be submitted.

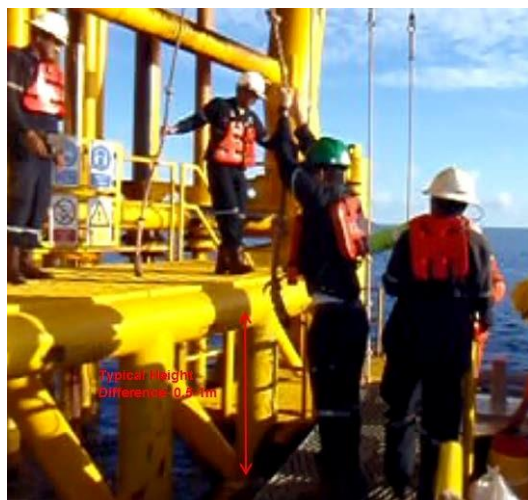
The difference in heights between the platform boat landings and crew boat decks can be between 0.5 to 1m under static conditions. This height can increase to as much as 1.5-2m in a dynamic environment. Vessel crew must ensure that passengers are using the swing ropes to effectively swing across and be ready to pull passengers across so that they land safely on the boarding area on the stern.

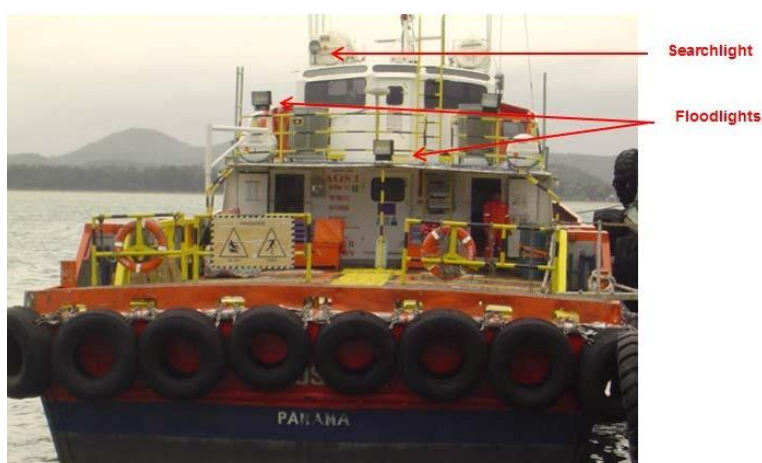
Adequate deck lighting is critical for any night time crew transfer operations. Deck Floodlights and stern deck search lights must be available to provide the required levels of lighting. In event of a MOB situation in darkness, the shipboard team must use the stern search light and/or flood lights to be directed towards the person in the water and visual surveillance maintained at all times by the deck team.

2. Night time swing rope transfer operations pose a higher risk due to greater difficulty in judging vessel movement and recovery of persons from the water. Deck crew must deploy rescue equipment rapidly and to maintain visual surveillance of person(s) in the water. Deck search and flood lights must be directed to locate the person(s) in the water and to guide the Master to position the vessel in a safe but proximate location to expedite recovery.
