Marine Safety Flash

A16-35 (14th September)

Vessel runs aground

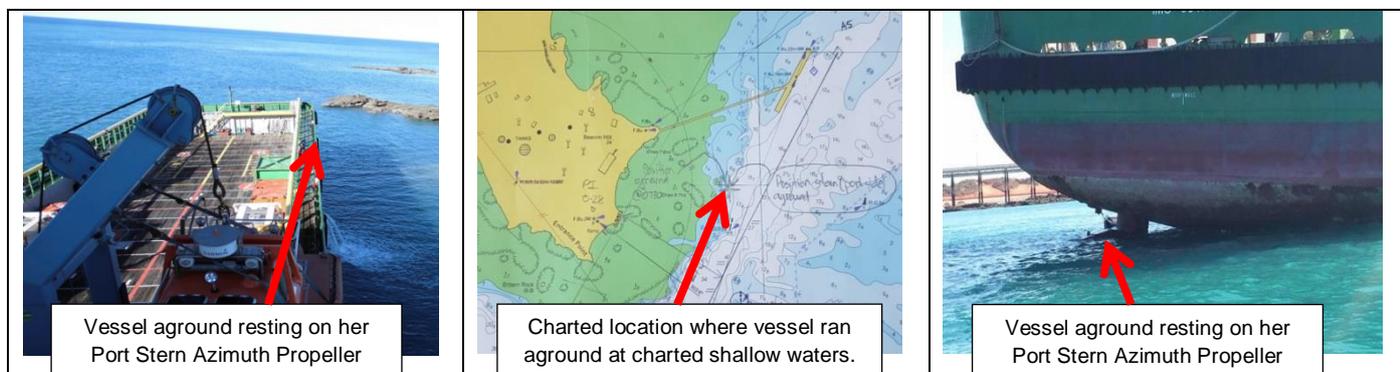
Vessel was making way through water at a speed of 5-6 knots. When vessel was around 150mtrs from berth, vessel speed was reduced and Master swung the vessel to starboard and started manoeuvring the vessel towards the wharf. Around 50mtrs from the wharf, Master noticed that vessel was not responding to his engine commands, multiple alarms commenced sounding and the vessel's stern started swinging out to port with the bow to starboard. Bow thrusters were used to guide the bow away from the wharf and slow down the swing to starboard. Amidst correcting the vessel movement and panic within the bridge team, emergency stop for bow thrusters was activated.

The port anchor was dropped in the water. Vessel swung to the tide but was still drifting, Master called to drop the second anchor. However, vessel drifted to ebb tidal currents and grounded 400m SSW of the wharf. No breach of hull or pollution was reported.

- The crew must understand the importance of adherence to the bridge team management procedures.
- Effective and closed loop communication between the bridge and engine room team is essential.
- Anchors to be on standby when arriving/departing port or during restricted passages.
- Bridge Team should be effectively trained in emergency procedures and contingency controls of all bridge equipment.
