Marine Safety Flash

A16-37 (14th October)

KLAW Break away activated inadvertently

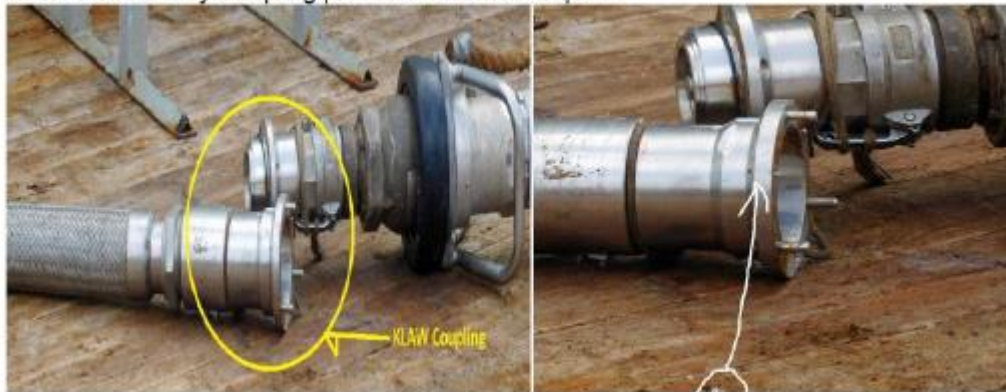
A support vessel was preparing to discharge methanol. After completing all necessary checklists and pressure testing, the vessel commenced the transfer and the “KLAW Break Away Coupling” on the vessel’s hose was activated inadvertently. The coupling functioned as per its design, with both flaps closing upon activation, and in doing so prevented a spillage.

KLAW Break Away Coupling photos after it broke apart:

- To fully inspect the couplings on-board for any signs of damage and fatigue.
- Review and revise existing JSAs for operation to ensure these couplings are handled with care and must be kept horizontal during loading & discharging operations.
- Continue performing maintenance as per Manufacturer's Maintenance Manual.

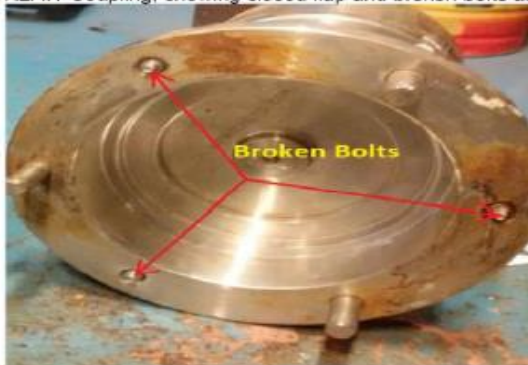
A full investigation was conducted and it was found that the bolts securing the coupling failed unexpectedly, causing the coupling to activate. The root cause was found to be improper rigging of the connection during routine transfers in port. This led to lateral stress on the coupling and therefore undue strain on the bolts.

KLAW Coupling, showing closed flap and broken bolts after breaking away
