# Safety Flash A12-13

**Issued: 15<sup>th</sup> September 2012**  
**Subject: Shower resulting in eye injury**

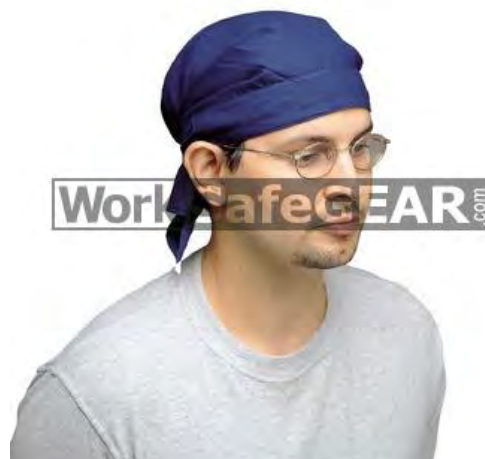
**Figure 1: Example of head gear**

- Risk assessment reviewed to capture post task cleaning/precautions
- Additional PPE to be implemented such as a bandana or cap which will keep particles out of hair. Example as per figure 1 below.
- Even though a task is completed and stowed away / secured, there still could be underlying hazards which need to be properly identified and managed
