Safety Flash A12-16

Issued: 15th December 2012
Subject: Laceration to hand from wire strapping

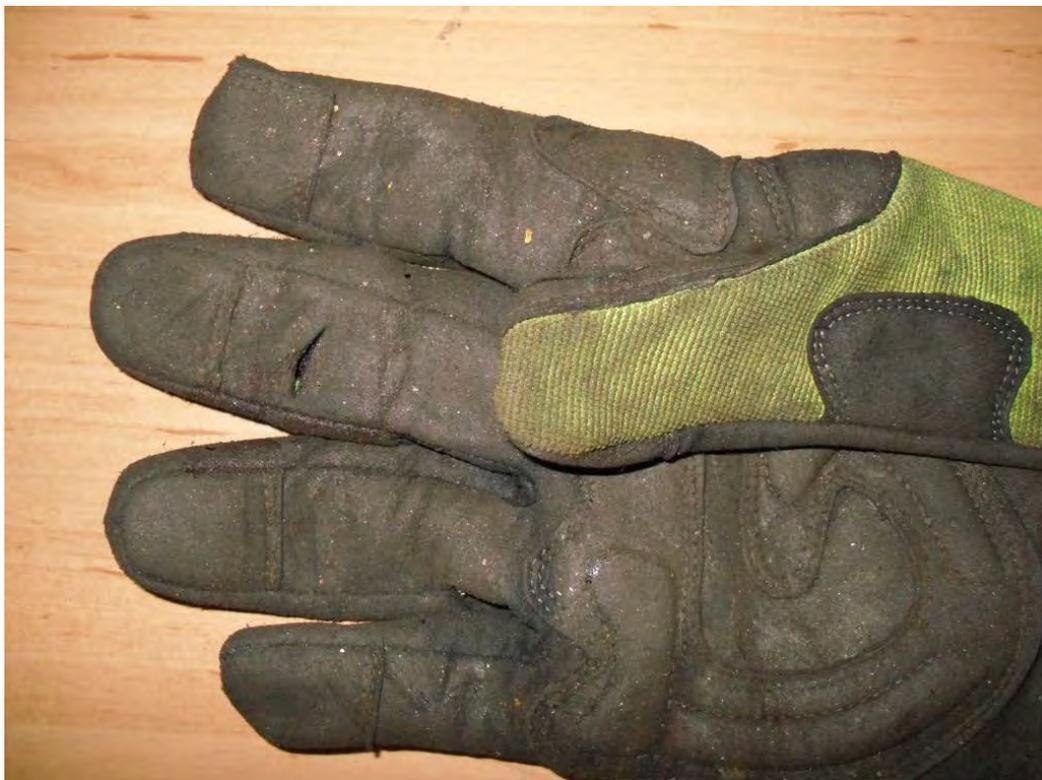
Photo #1 – Glove in use showing cut inside middle finger

- The cause of the laceration was by the steel strapping cutting through the glove. The glove was later identified as the wrong type for this task. The glove in photo #2 was a more appropriate choice.
- The hazard of laceration was not identified in the risk assessment and hence not controlled adequately.
- The agreed plan was not followed. The job should have stopped and the PCP passed back to the installation to remove the lashings as per the plan.

- Pre-task planning should remain throughout the cycle of the operation, unless a change in the planned operation requires a new plan to be adopted. In this case, the change of plan should be communicated to all key stakeholders to ensure adequate time to manage the change.
- Stop the operation if there is a change of plan. Revert to existing plan if there is no justification for the change.
- Review and amend Job Hazard Analysis (JHA) for this task to incorporate laceration hazard, and introduce robust controls to manage this.
- PPE management through the life of an operation. Identify what gloves are required at each step and change accordingly.

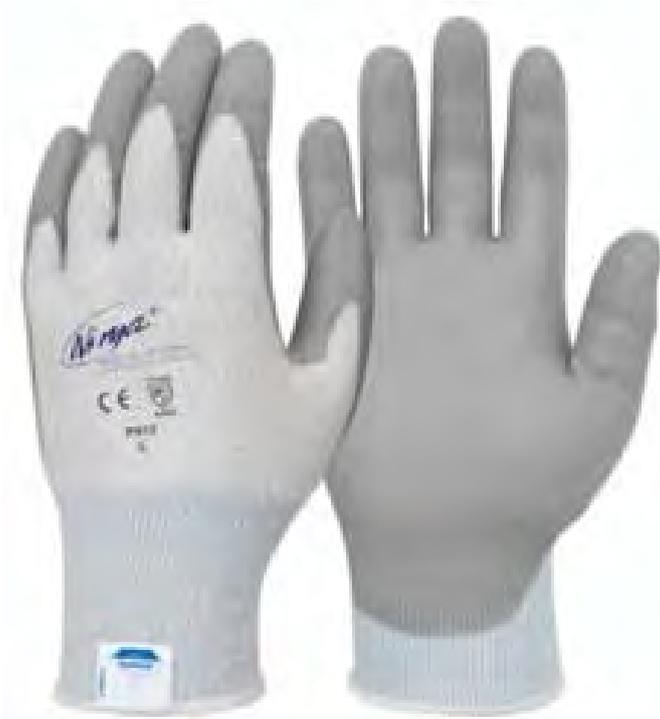
Photo #2 – Correct glove for handling steel strapping
