Marine Safety Flash

A13-12 (15th September)

Ankle Injury

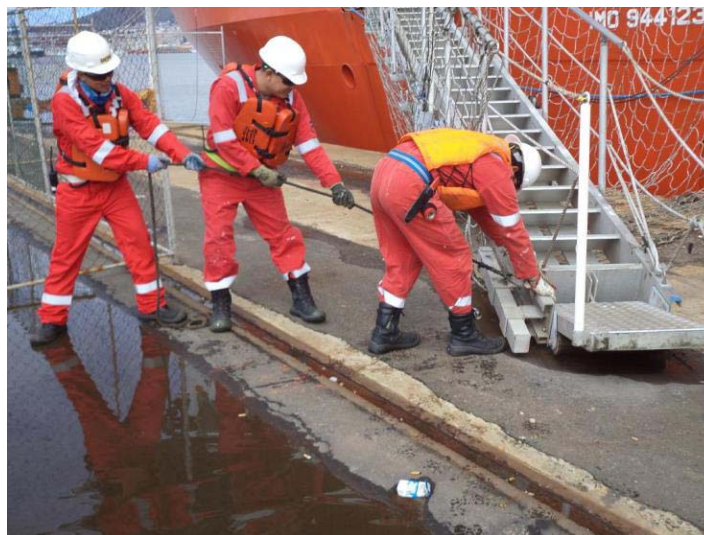
The IP was pulling the gangway and required additional manpower. The IP requested the assistance of the shore linesmen who began pulling the gangway as directed by the IP. The IP appeared to be in the wrong position and his foot became stuck under the gangway's roller. After the gangway was heaved up by the linesmen, the IP managed to remove his foot from under the gangway, moved away and lay down on the jetty.

- A rope was in place for pulling over the gangway and to ensure a safe distance from the gangway and roller while movement was taking place. In this instance the IP took hold of the gangway rather than the rope, placing himself in the proximity of the roller when the weight was taken by the linesmen.
- On further investigation it was identified that the IP had not been involved in this task before and the job was not adequately supervised. There was no toolbox talk held and communication before and throughout the task was inadequate.

- Adequate job planning must be carried out, identify the right personnel and the competence required in order to do the job safely.
- Toolbox talks to be held prior to gangway operations.
- New or unfamiliar personnel must be supervised and mentored until they are familiar with the job.
- STOP the job if you feel uncomfortable with the job taking place.
- Additional ropes to assist more people in moving the gangway from the safe position.
