# Marine Safety Flash

## A14-01 (15<sup>th</sup> February)

### Slipped on Gangway

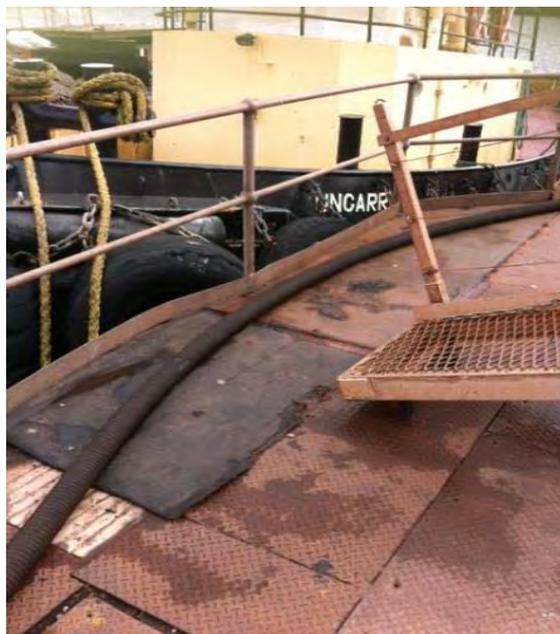
Descending the gangway from tug to jetty, the IP lost footing, slipped off the end of the gangway onto a rubber hose and rolled his ankle. It caused several bone fractures, tendon damage and severe pain.

- Tide was spring high resulting in very steep gangway (Note: image taken at lower tide condition)
- Gangway had inadequate non-slip surface for the purpose and no slip-limiting cross treads / bars
- Temporary sullage hose had been left rigged due to another vessel requiring frequent bilge suction, but this had not been risk assessed and the hose was left in walkway areas instead of safer position such as up against or hanging on nearby railing.
- Industrial footwear being worn was non-slip but did not have a heavy duty tread pattern
- IP was carrying a bag in one hand, so only had one hand to arrest fall
- During investigation it was identified previous incidents of both slipping on the gangway and tripping on the temporary hose had occurred but not been reported and hence not investigated

- Hose was removed and stowed in its permanent stowage position between jobs.
- Gangway decking mesh was fitted with slip limiting cross bars
- Lessons learnt are being transferred to future design of gangways for new vessels coming to the port.
- Basic seamanship and precautions –
  - Ensure both hands are free when climbing steep gangways by passing bags and equipment between vessel and the shore by crane or heaving line rather than hand-carrying.
  - Use mental “Take-5” whenever conditions change or new conditions appear
  - Ensure PPE, particularly footwear are fit for purpose and protect the ankles
- Proactive Reporting – This incident could have been avoided had previous observations, similar near misses and minor incidents been reported, investigated and preventive actions taken as a team.
